This Thesis Report titled
RESURRECTING ABANDONED INNER CITY RELIGIOUS
BUILDINGS AND CAMPUSES AS COMMUNITY AMENITIES

Resurrecting Abandoned Inner City Religious
Buildings and Campuses as Community Amenities

Thesis Report

Submitted to the
Faculty of Miami University
in partial fulfillment of
the requirements for the degree of
Master of Architecture

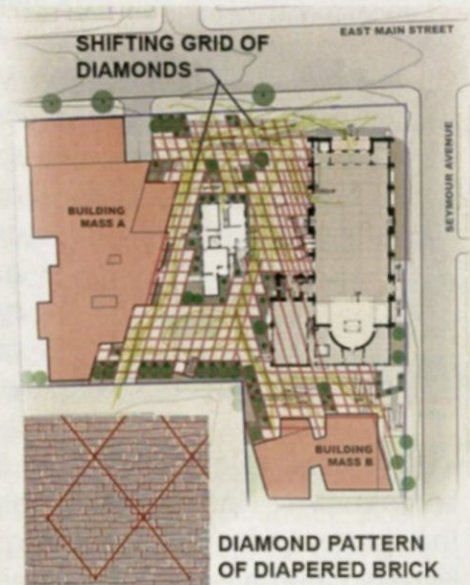
Figure 4 - Site diagram demonstrating how the diamond pattern is incorporated into the site design

When approaching the redevelopment of these former church campuses into engaging community oriented spaces, a variety of factors should be considered. Designers should consider the design elements that are found in the historic architecture on the site, to create spaces that welcome all and draw people in through obvious pathways. In redeveloping these sites, the architectural features of the site should be analyzed and the designer should select specific elements to reference in their design in an effort to connect the new to the historic. The designer should not attempt to replicate elements of the style of the existing architecture as to blur the line between what is old and what is new. Such a distinct line is of critical importance in the insertion of new elements into historic buildings as not to create a false sense of history. One of the most distinctive features found in the former Holy Rosary sanctuary building is the diamond patterns found in the diapered coursework of the brick facades of the building. Pulling the diamond pattern from the diapered brick, a grid is created that is then rotated and placed along the well defined line of the buttresses along the west wall of the sanctuary hall. Using the resulting grid of shifting diamonds, engaging paths of travel are arranged along this grid that pull people into specific attraction points that employ compression and release. Similar to that of the traditional entry to a church where one experiences the compression of the narthex before the release of the vast space of the nave. Using the resulting grid of shifting diamonds, engaging paths of travel are arranged along this grid that pull people into specific attraction points that employ compression and release. Similar to that of the traditional entry to a church where one experiences the compression of the narthex before the release of the vast space of the nave. These narrow passages for pedestrian travel between the densely packed buildings mimic those of the immediate surroundings of churches and cathedrals in medieval cities in Europe that these the structures emulate the style of. These European churches and cathedrals are staged as

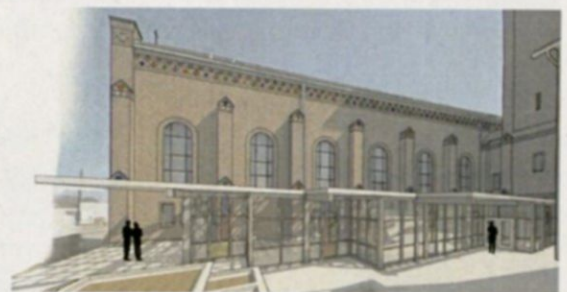
Figure 8 - sketch rendering showing how new structure hangs below the lower horizontal band of the sanctuary allowing the colored tiles to remain exposed.

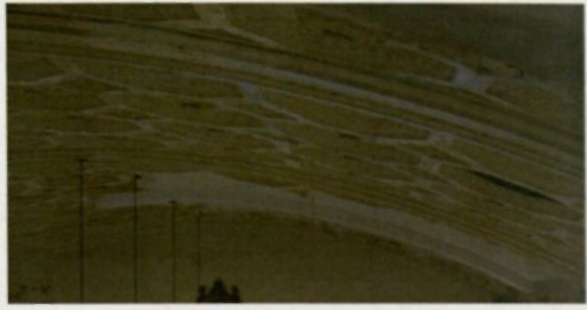
Figure 9 - Photo of Stony Island Arts Bank showing detail of patching missing plaster coffered ceiling with smooth layer set back

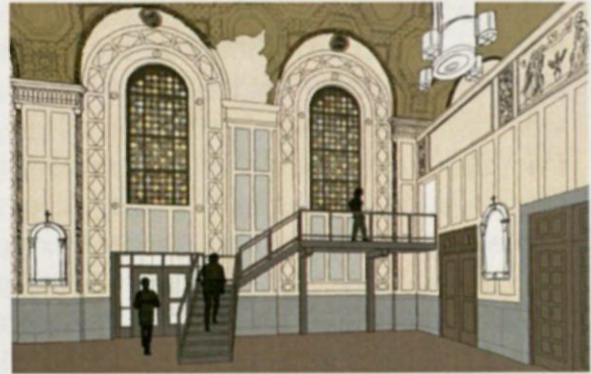
Figure 10 - Rendering of interior showing new stair to mezzanine along with ceiling repair and interior painting strategy.

The former Holy Rosary Sanctuary has damage to the vaulted ceiling in various spots with one of the main pilasters having had its column head destroyed. Creating a new column head that mimics the historic in form while being a modern simplistic take on this highlights how this pilaster has been rebuilt new. The holes in the decorative coffered vaulted plaster ceilings should be patched with a set back smooth plaster finish to contrast the scars in the ceiling from the preserved portions. This is similar to the technique utilized at the Stony Island Arts Bank in Chicago where damaged portions of the coffered ceiling are revealed with a setback smooth layer of plaster that also fills in missing ribs of the vaulted ceiling. Sanctuary halls are typically darker spaces that are painted in darker tones and in the case of the former Holy Rosary it was historically painted darker colors but portions of the lower walls have been painted over with lighter tones over the years. In an effort to brighten the space, the lower walls will uniformly be painted a lighter off-white color in order to brighten the space. If new elements are to be inserted into the sanctuary hall space they should be done in a way that does not dramatically impact the vast space of the nave while also opening up new circulation paths. A new stair element is added within the sanctuary hall to provide access to the former choir mezzanine creating an open path that also leads up towards the elevator. This minor stair element brings users closer to the stained glass windows and the decorative plaster while keeping them just out of reach as it cuts back into the choir mezzanine to lead up to the landing.

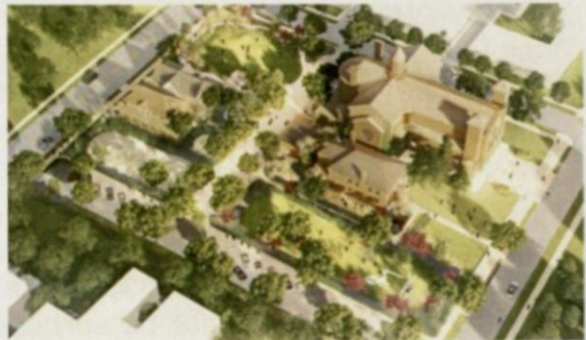
Figure 11 - Site rendering showing the overall scope of the project

This project seeks to redevelop the former church campus into a cultural arts center that will be home to various gallery spaces, a sculptural garden park space, and the skatepark. This program for the site, incorporates various art focused spaces into a communal center while also providing large green spaces to be utilized as park space by the community along with recreation with the skate park. A long pedestrian pathway is sliced through the center of the site, repurposing a formerly alley that had been abandoned that runs along the rear of the sanctuary hall. This path slices down the center of the site connecting the various buildings of the site and is lined with trees. The designers went out of their way to do very little to alter the exterior architecture found on the site with most of the changes having to do with the interior and landscape design. Public lawn spaces that are placed around the historic former church buildings over the sites of long gone buildings that had once been part of the campus such as a former school and nunnery. (Our Lady Queen of Heaven - Good Shepherd Catholic Church) One of the public lawn spaces is a sculptural garden dedicated to the late famed Detroit sculptor Charles McGee highlighting how this site is also home to a new library focusing on the works of African American artists of Michigan. (Library Street Collective) Two historic houses on the opposite side of the block as the church buildings are incorporated into the site through a new porch structure that wraps around both buildings combining the two structures into a new engaging gallery space that is adjacent to the skate park. Through circulating travel down a central pedestrian corridor, visitors are given a wide view to the various programatic elements that occupy the site. This corridor is referred to by the landscape architects as "the Nave" likely referencing how similar to the nave this corridor acts as a long path that connects the various programs of the building / site. (OSD Outside) The former sanctuary hall is repurposed into the main gallery spaces with several smaller gallery rooms inserted into the nave. These inserted elements are a modern design that contrasts the historic architecture, and create new paths of travel around the sanctuary without blocking the central path of the nave. In effort to brighten the interior spaces that only receive natural lighting through

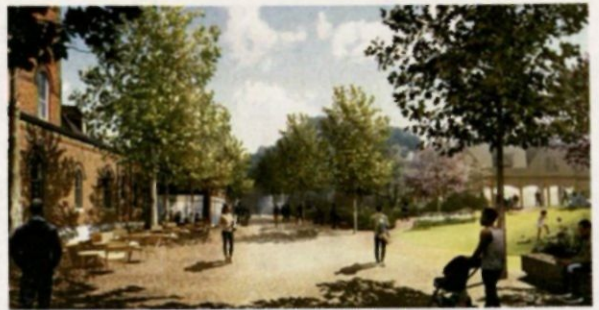
Figure 12 - Site rendering showing the overall scope of the project

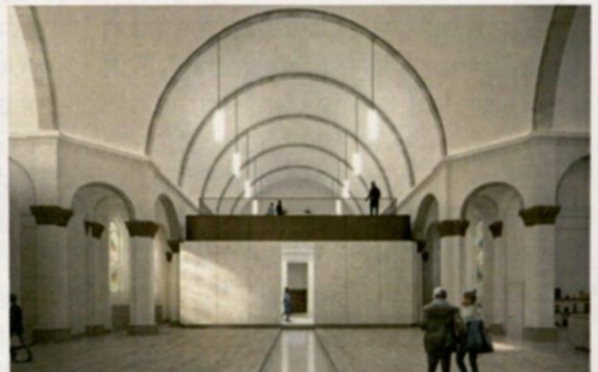
Figure 14 - Rendering showing one of the inserted gallery element with central slice cutting through it that extends the mezzanine out

darker stained glass windows, they repainted much of the interior white. While this removes the murals of religious scenes that once highlighted the ceiling, the space is dramatically brighter than it was before. The historic flooring is torn out with much of it having been damaged from the removal of the pews, with a new floor grid honoring where pews had formerly been placed with wood flooring while leaving a concrete path that exposes the historic paths of travel that existed in the sanctuary. The designers also added accessibility to the building through a simple ramp at the side entrance along with opening up the mezzanine through a lift that allows for easy accessibility to a formerly inaccessible area allowing for more people to experience the views offered from the upper floor. The mezzanine space is extended out over the new gallery elements allowing for visitors to get up close to the vaulted ceiling.

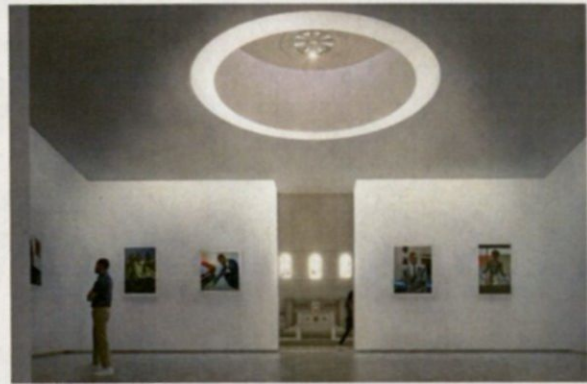
Figure 15 - Rendering showing the interior of the gallery element with the slice exposing the path towards the altar and a opening exposing the vaulted ceiling.
Source: Peterson Rich Office

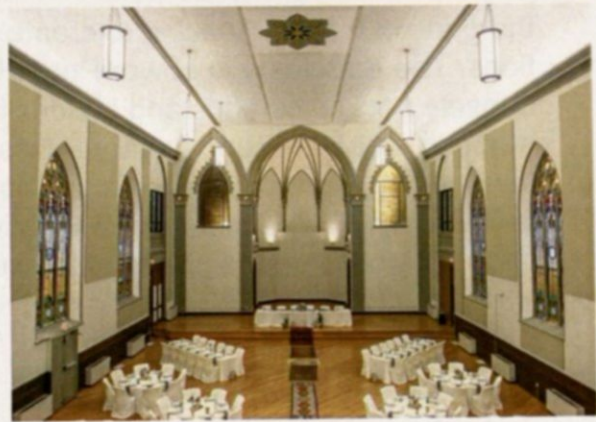
Figure 17 - Photo of the interior of The Sanctuary showing how the acoustic panels frame the historic features and the space is brightened with light paint
Source: Cincinnati Refined

the former church buildings all being close together with narrow parking lots between, few opportunities for community spaces are available around the campus buildings. The Community Matters organization has spread their efforts elsewhere instead with further developments such as developing a community garden across from the Sanctuary and the opening of a coin operated laundromat. (CityBeat Staff) In restoring the buildings on the campus Community Matters worked with architect, Brashear Bolton and HGC Construction to revitalize the buildings on the campus. (HGC Construction) With funding from historic tax credits, modifications made to the existing architecture were minor in effort to best preserve the architecture of the site within a tight budget. Minor alterations were made at the sides of the sanctuary building providing side ramps that make the spaces accessible. With much of the interior detailing having been striped away or damaged from neglect when the catholic church closed, the interior was painted a white color to brighten the space along with the addition of acoustic panels throughout. Having a sanctuary hall that is non-intricately detailed allows for ample room for these panels as they serve to frame the historic features of the building.

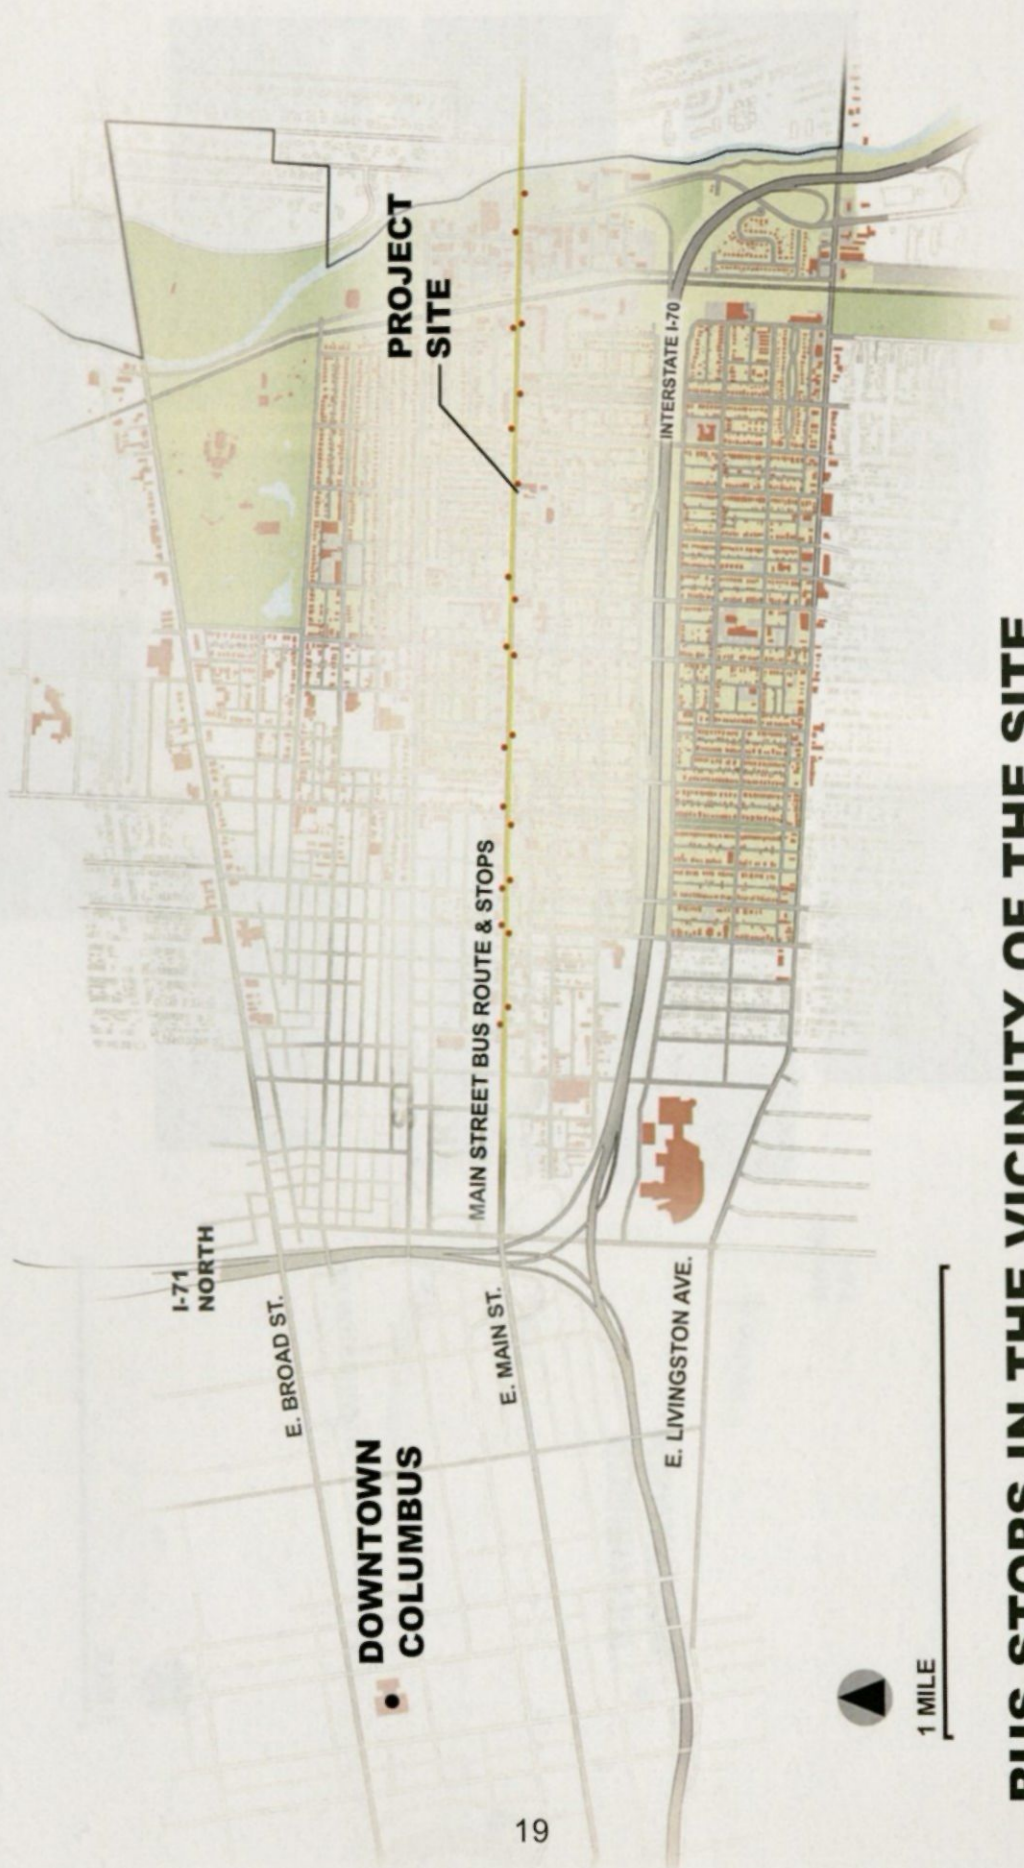
BUS STOPS IN THE VICINITY OF THE SITE

THIS SHOWS HOW THERE IS A BUS STOP RIGHT IN FRONT OF THE SANCTUARY BUILDING MAKING THE SITE EASILY ACCESSIBLE FROM PUBLIC TRANSIT

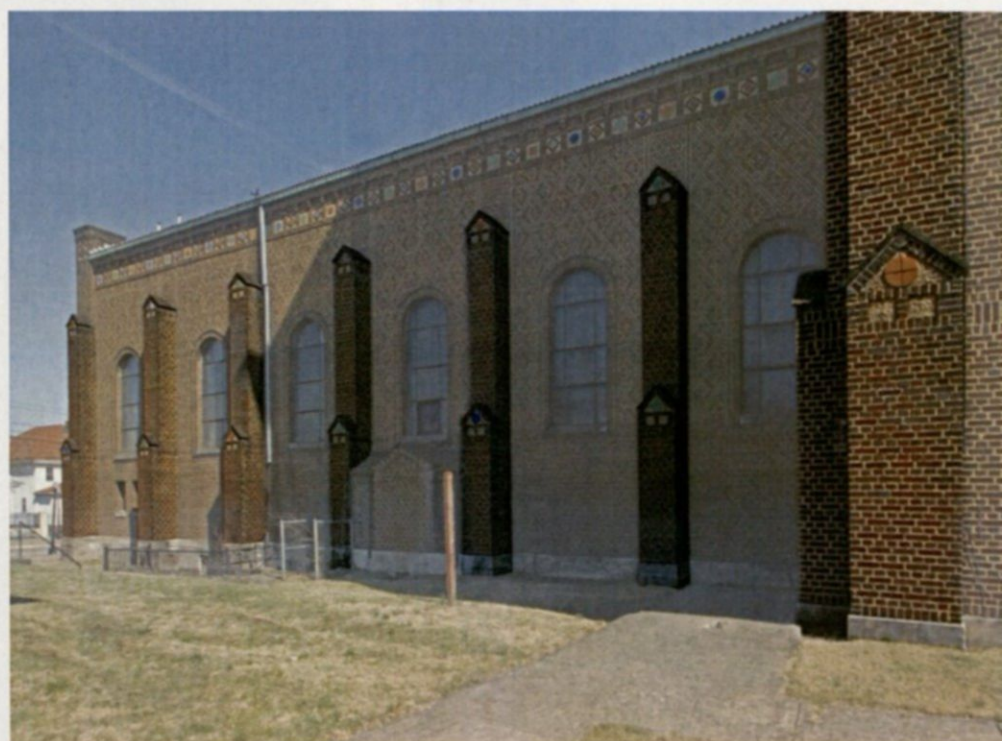
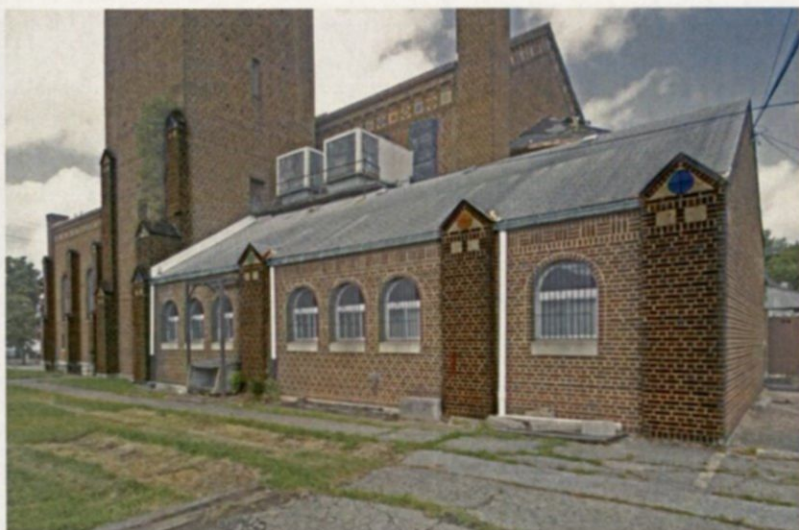
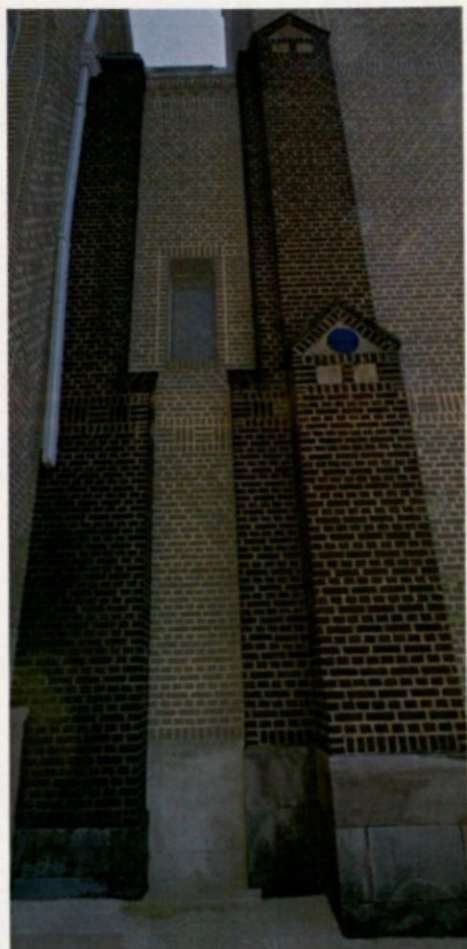
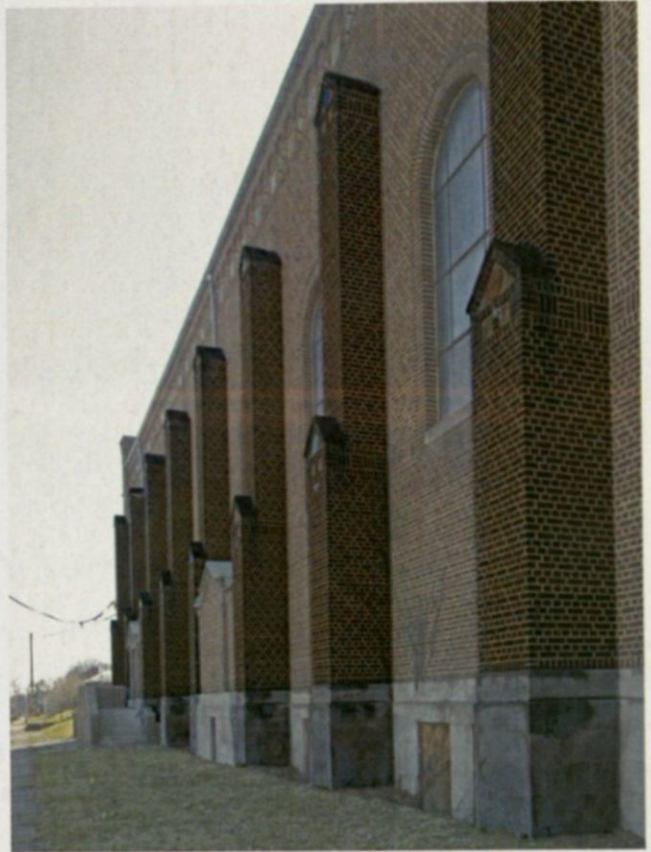
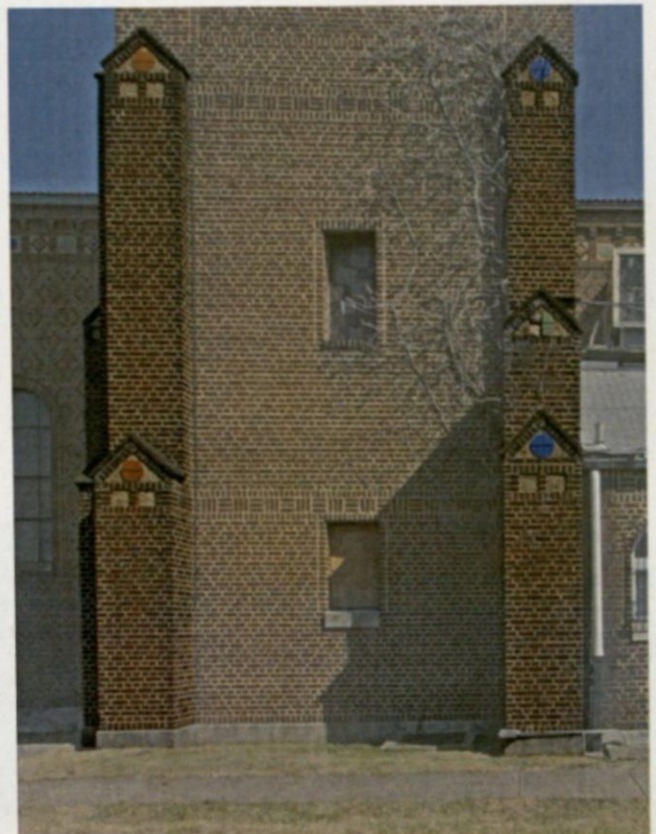
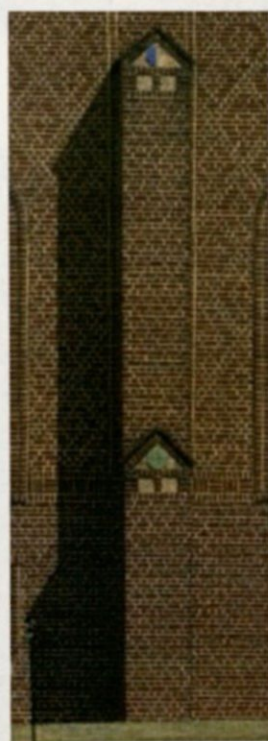
COLORED TERRACOTTA TILES

A variety of segmented colored tiles add color to the building in various locations such as the frieze of the main sanctuary hall, top of the campanile, the southeast chapel frieze, and each of the buttresses. The frieze of the sanctuary building is decorated with varied tiles switching between diamond tiles and square or circular tiles. The tiles in these elements vary in color with blue, red, orange, and green tiles placed in no specific pattern. Each of the buttresses is decorated with two segmented circular tiles of varied colors at each point in which the buttress steps back into the facade. Between the arches at the top of the campanile are green segmented circular tiles with the frieze above decorated with blue diamond tiles.

The conditions of these tiles vary with most being in tact. Some of the segmented tiles are either missing portions or are completely gone. Replacing these missing tiles should be done. Avoiding covering up the tiles with additions should be avoided to preserve the defining colorful element of the historic building.

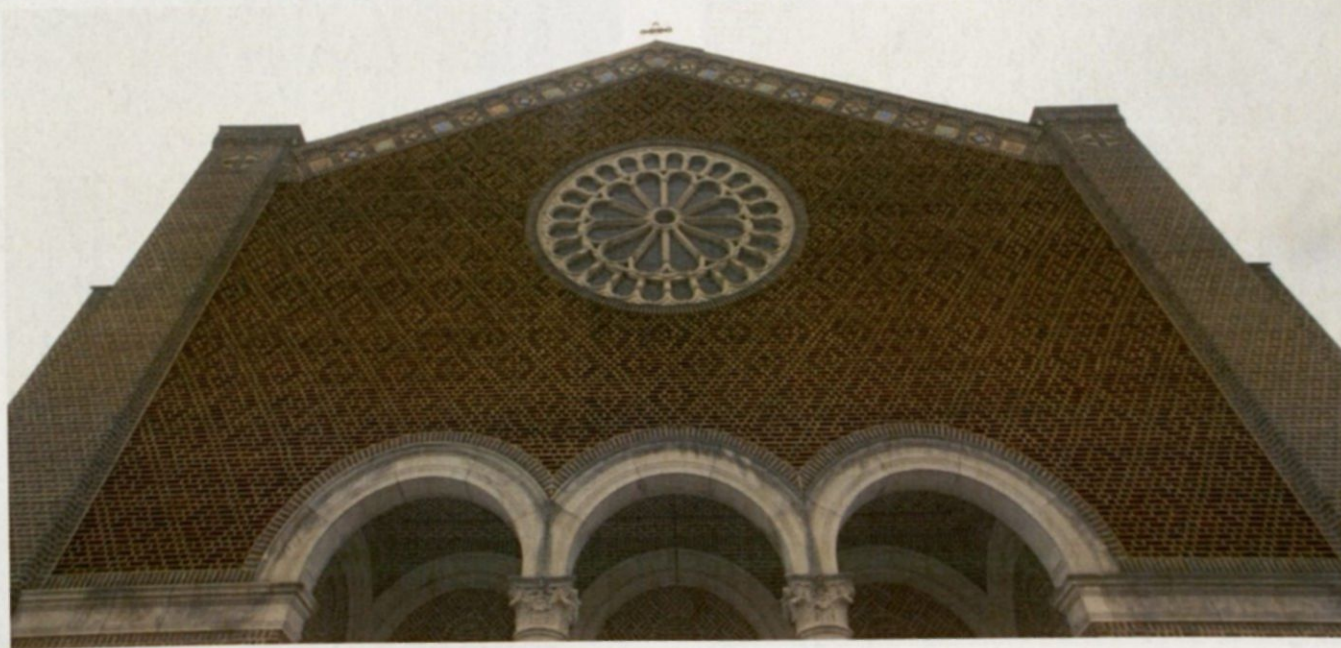
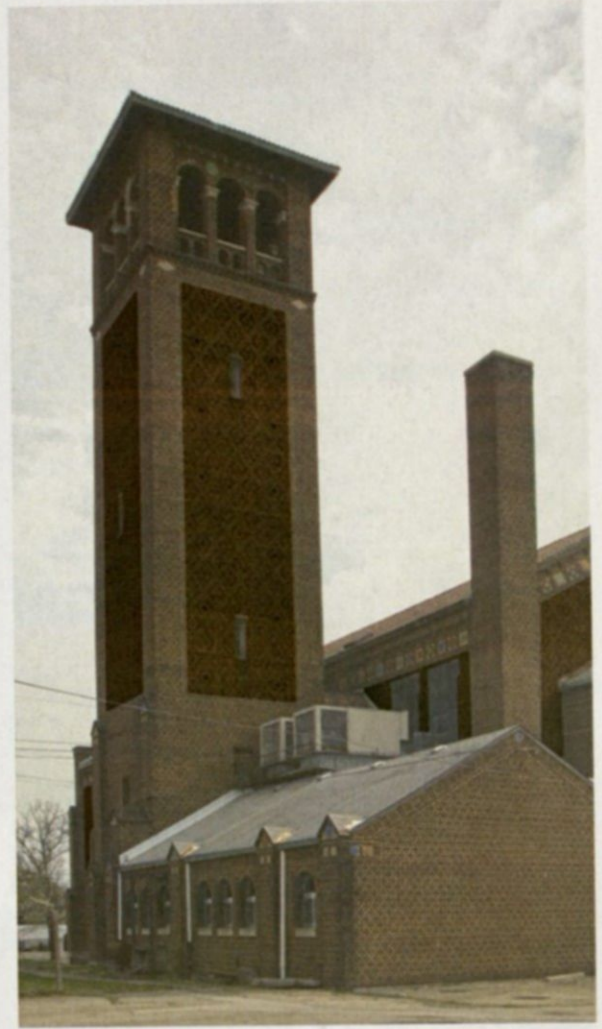
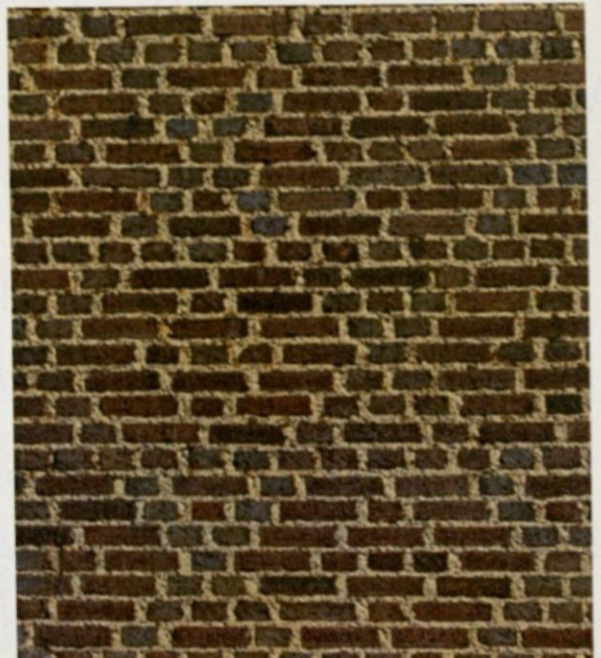
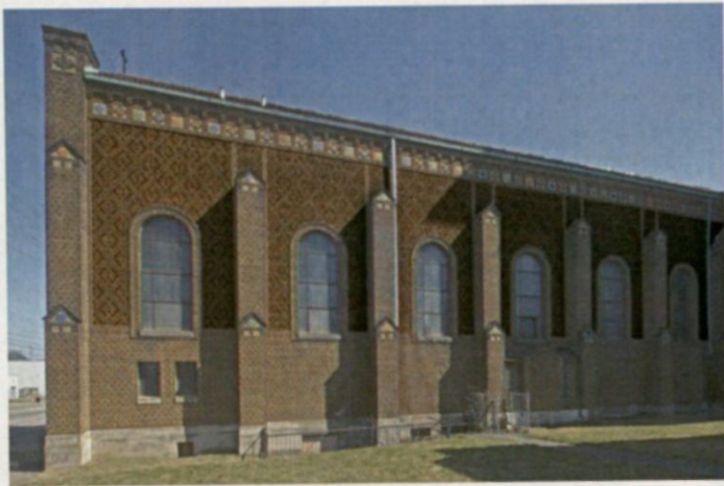
HORIZONTAL BRICK BANDING

Horizontal bands of bricks composed of a two layers of soldier course brick with basketweave course between creating a hatched pattern infill can be found throughout decorating the facade. The lower horizontal band marks the sacristy roof lines well as where the sanctuary facade transitions to diapered brick. The upper band is featured at the top of each buttress as well as wraps around the campanile and its annex marking the the base of the tower as well as where the diapering of the brick begins in the facade.

The horizontal brick banding creates important datum lines in the facade's design. Any new elements added to the building should be respectful of these datum lines. The new additive piece should hang below the lower band as to not cover up the most decorative portions of the facade.

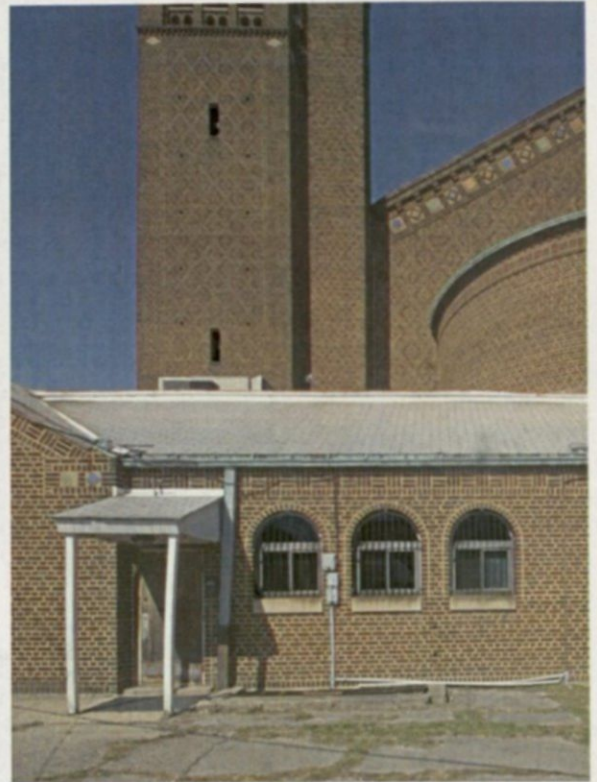
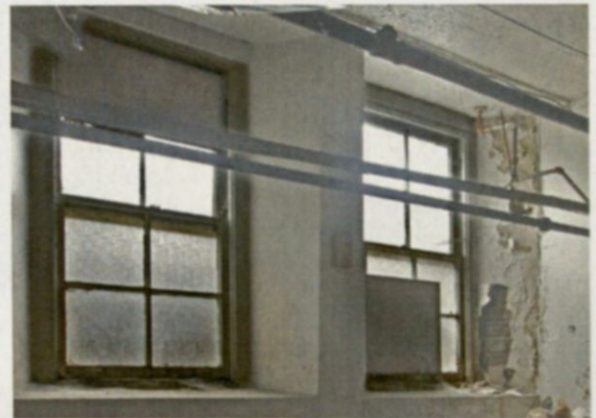
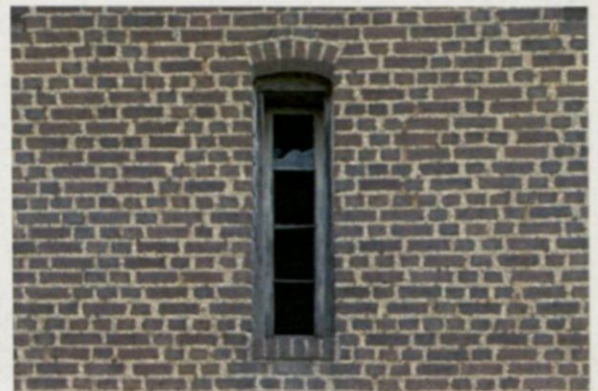
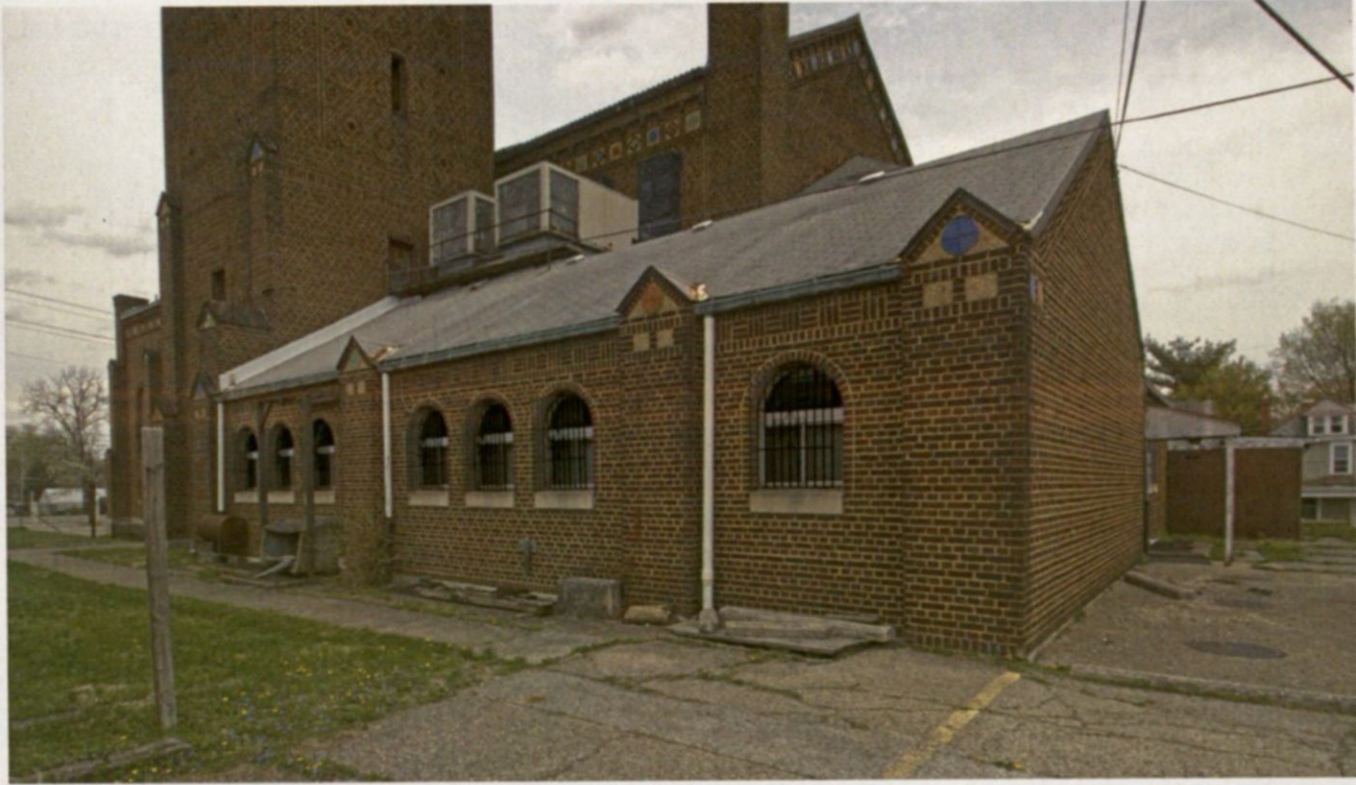
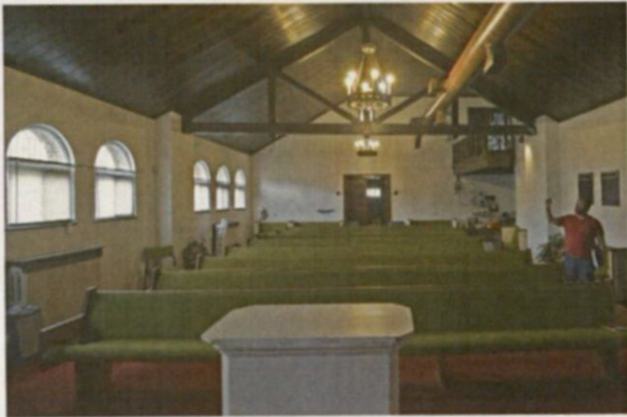
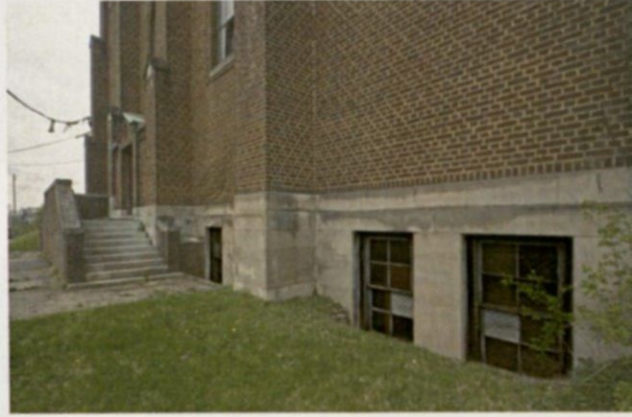
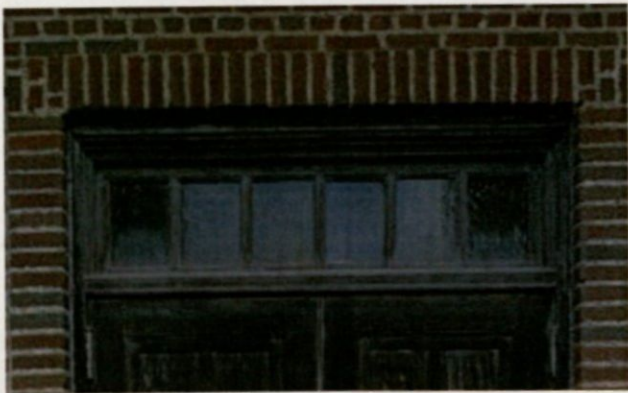
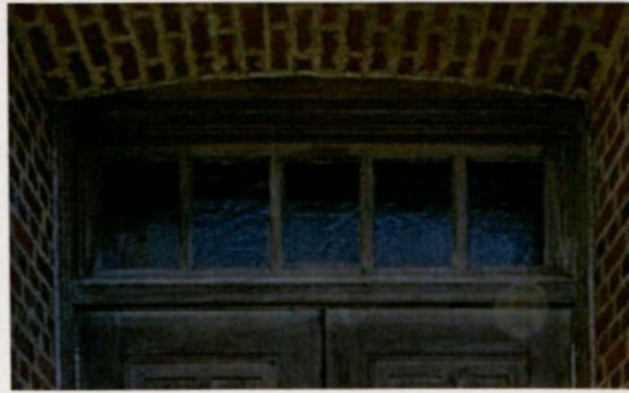
CLEAR GLASS WINDOWS

Various clear glass windows can be found throughout the sanctuary building in smaller window openings. At the ground floor there are four over four segmented hung windows with frosted glass panes. The campanile has several tall narrow windows that are segmented into four panes. The southern chapel and sacristy, features smaller arched windows that are infilled by more recent modern windows with clear glazing.

The windows at both the campanile and ground floor are in very poor condition and are historic wood windows. These windows should be replaced with new aluminum windows matching the patterns and sightlines of the historic windows. Frosted glazing should be used again for the ground floor windows to allow for privacy. The modern aluminum windows found at the rear of the building at the sacristy offices and southern chapel should be considered low priority for replacement.

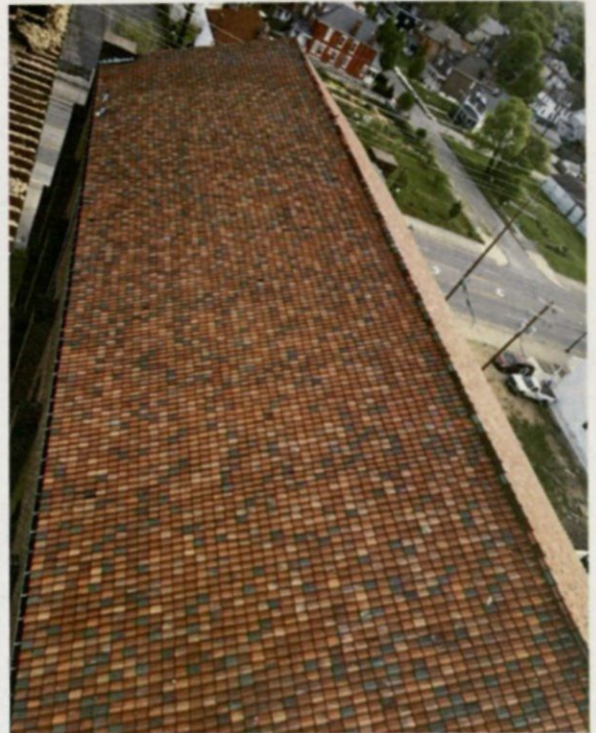
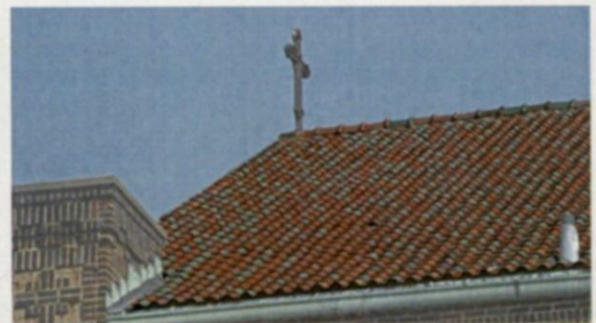
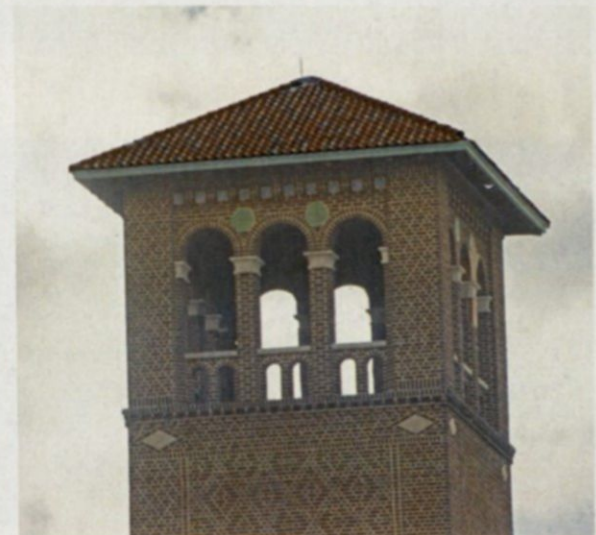
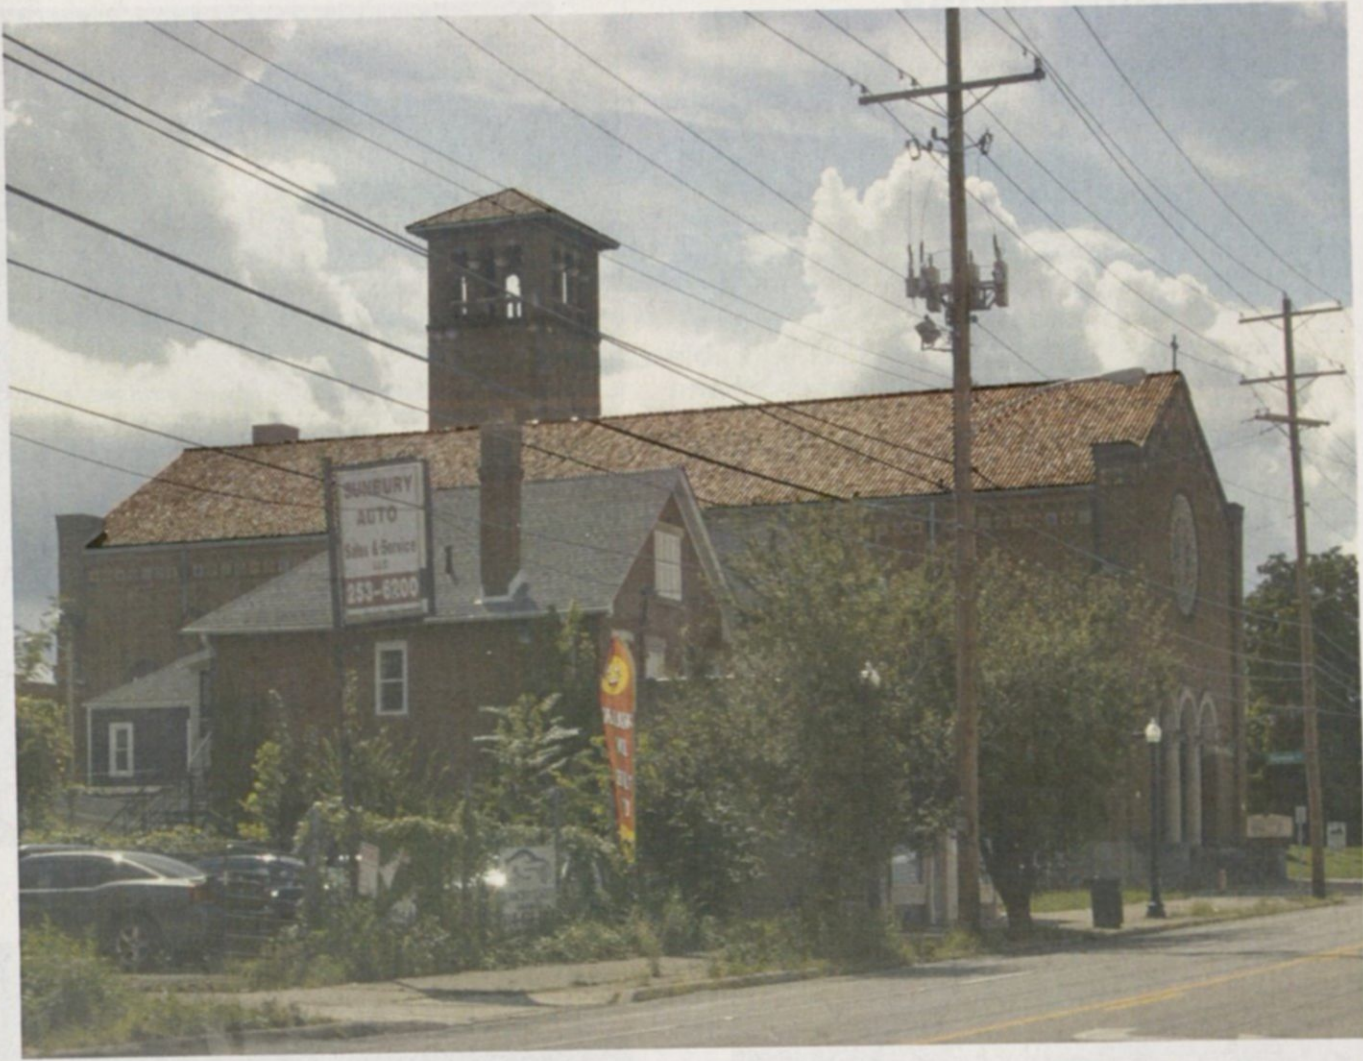
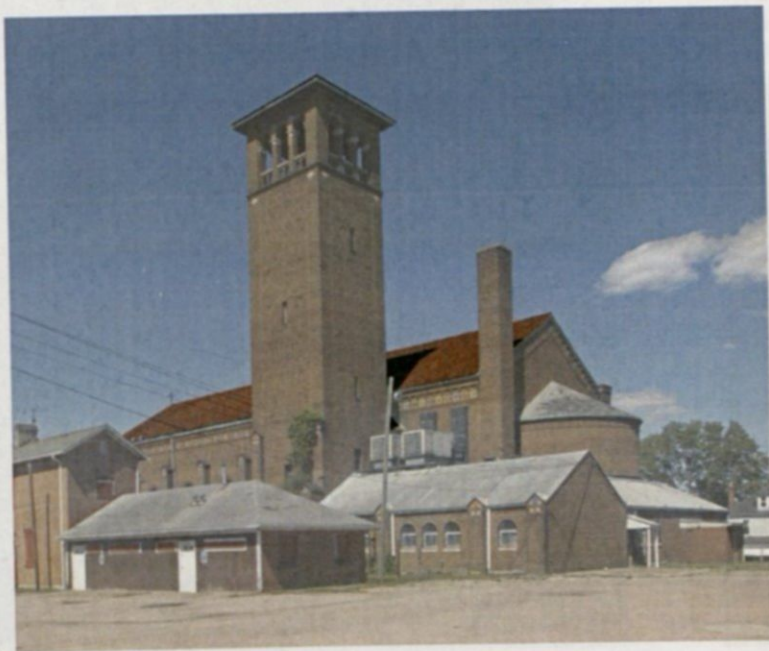
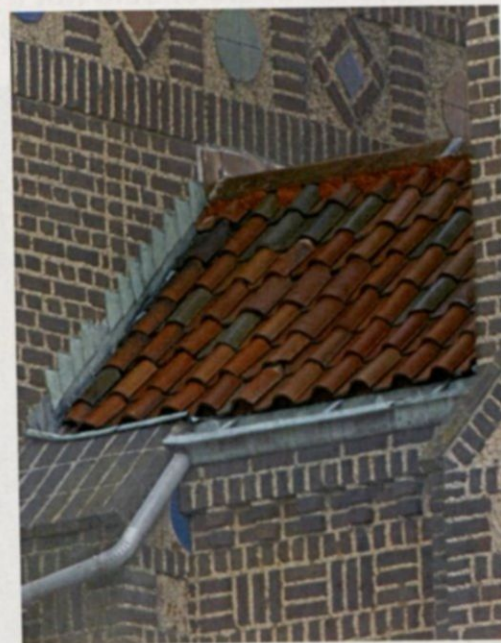
TERRACOTTA ROOFS

The pitched roof tops of the sanctuary hall feature varied colors of terracotta roof tiles. The main stretch of the sanctuary hall, the campanile and the part of the building connecting those two are topped with these terracotta roof tiles. The southern building forms used to have terracotta roofs but they were replaced at some point with asphalt shingled roofing.

Repair is necessary on the terracotta roofs with some of the tiles having damage. With the main sanctuary hall having experienced roof leaks, portions of the roof should be repaired beneath the tiles. While the southern building forms with asphalt shingles are important to the character, without the original roofing some of this character is lost so further alterations could be justified such as covering portions of the roof up with new building. New asphalt shingles should replace the existing to give the roof more of a color similar to the terracotta.

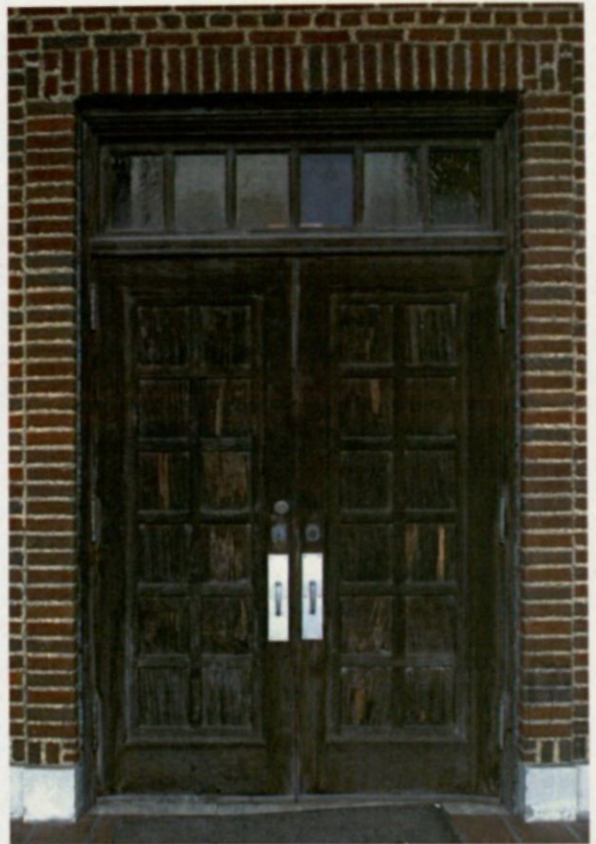
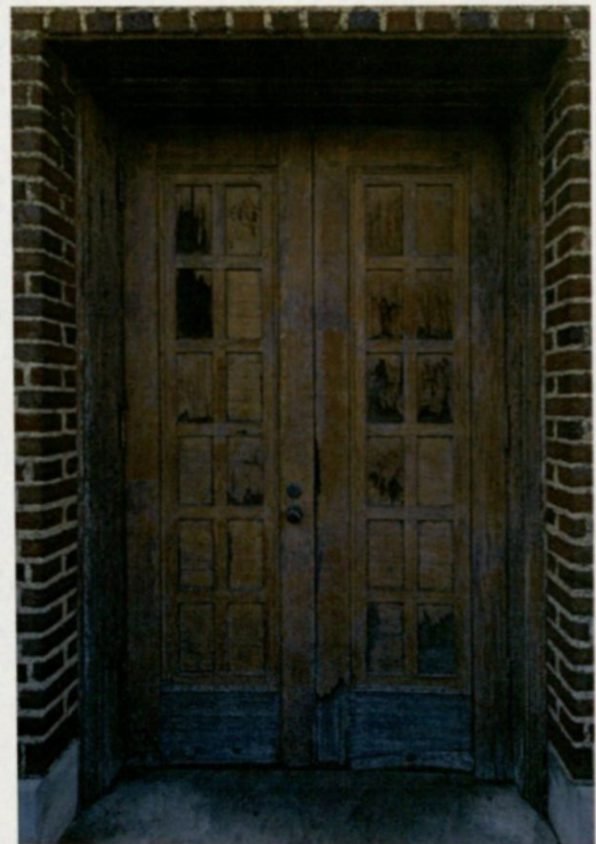
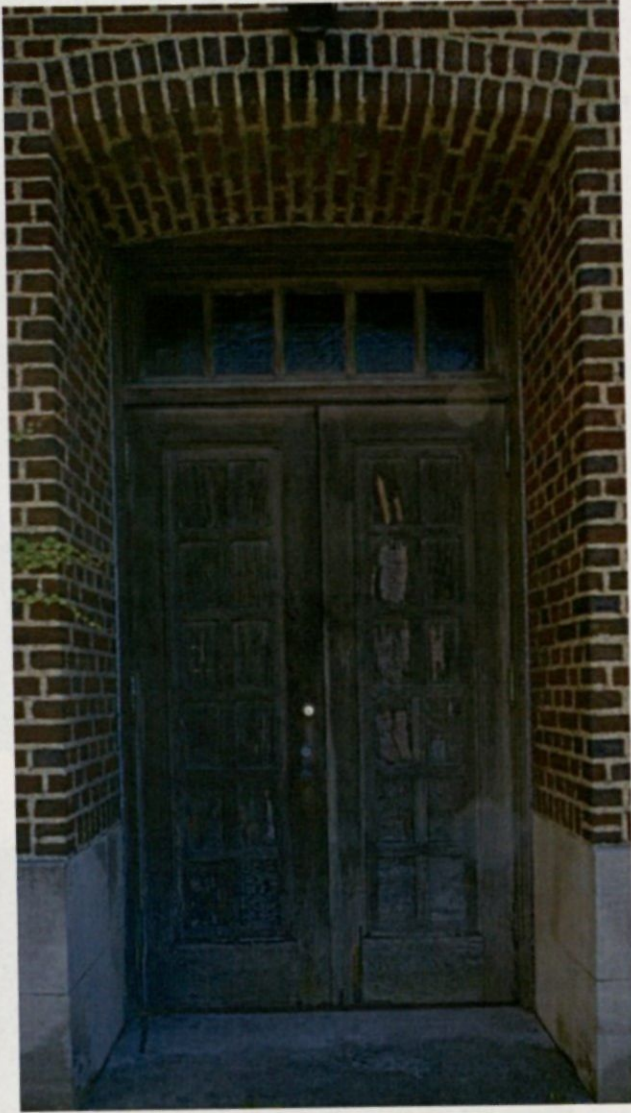
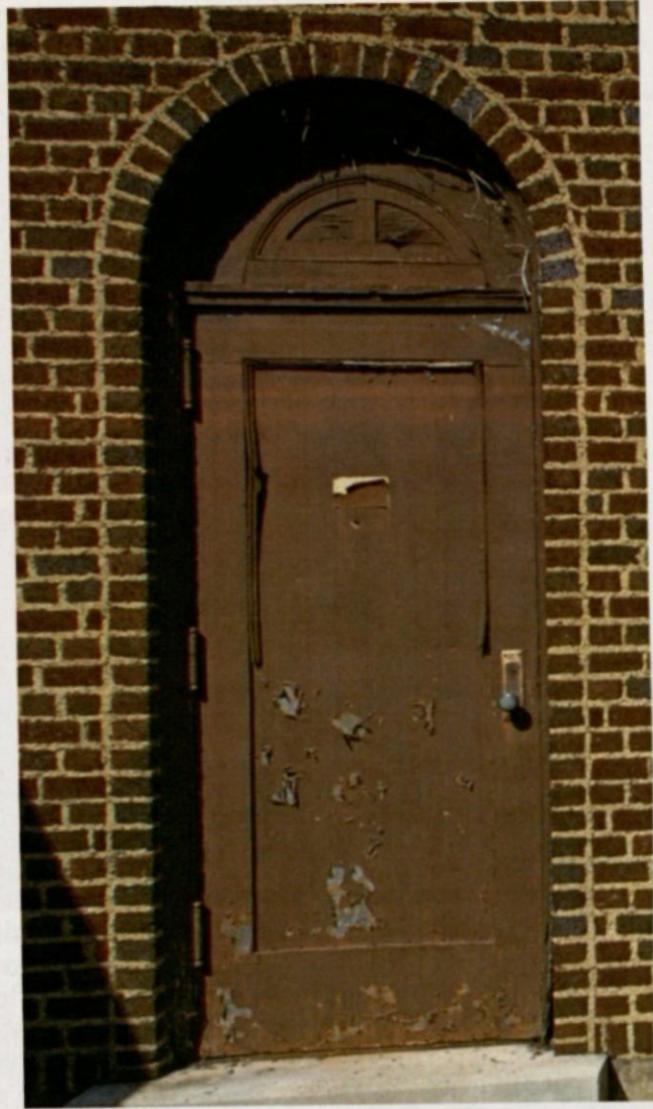
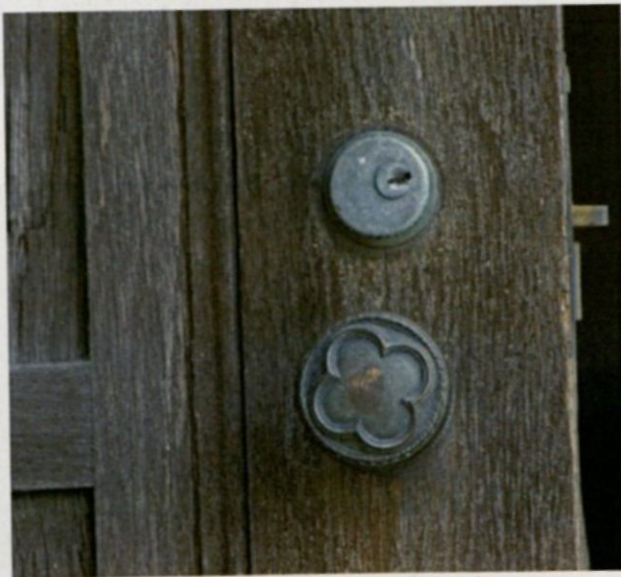
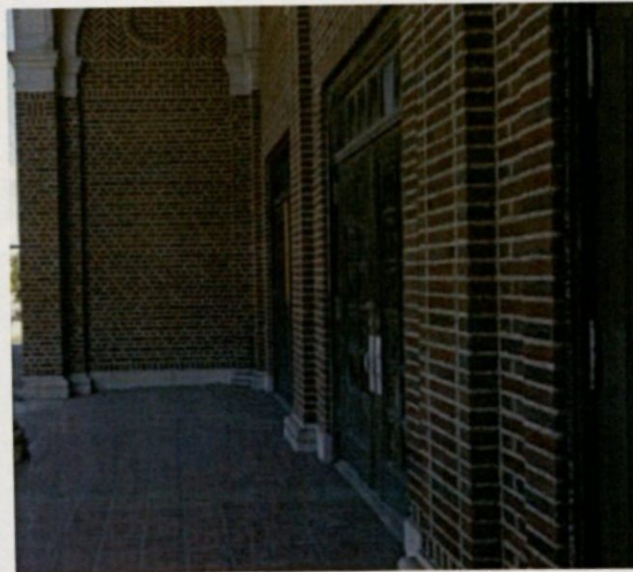
EXTERIOR DOORS

Solid wood paneled doors are found around the building at the various entry points. The entry porch has three wooden double door entries composed of two rows of six evenly segmented rectangular panels. The two side doors lack handles or any hardware while the center door has two modern handles, while at the interior historic decorative knobs are still on each door. The double doors at the eastern transept entry and the campanile base also feature similar patterned doors that are narrower. The campanile entry door has decorative historic door knobs similar to that found at the front entrance while the side door on the east has regular door knobs. At the sacristy wing, there are two wood doors, one of which is historic which is a segmented two with two rectangular panels on the exterior while segmented into twelve panels on the interior. The historic door at the sacristy has plain door knobs similar to those found at the side entry.

Repair is necessary on these doors in particular the side entrance doors which weren't as protected from the elements as the main entrance doors were. The doors should be repaired to match how they looked historically with new accessible hardware to replace any non-ornamental hardware. New exterior doors should not try to mimic the appearance of the historic doors as to differentiate itself.
