This Thesis Report titled
RESURRECTING ABANDONED INNER CITY RELIGIOUS
BUILDINGS AND CAMPUSES AS COMMUNITY AMENITIES

Resurrecting Abandoned Inner City Religious
Buildings and Campuses as Community Amenities

Thesis Report

Submitted to the
Faculty of Miami University
in partial fulfillment of
the requirements for the degree of
Master of Architecture

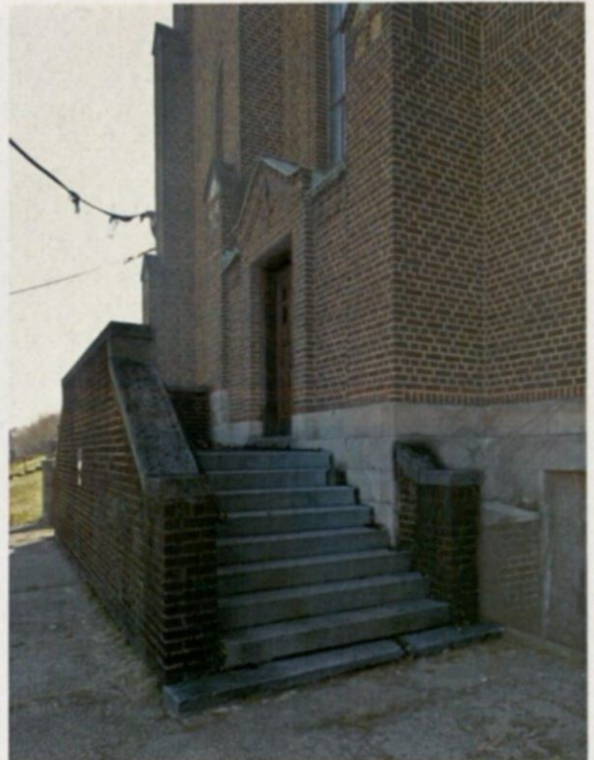
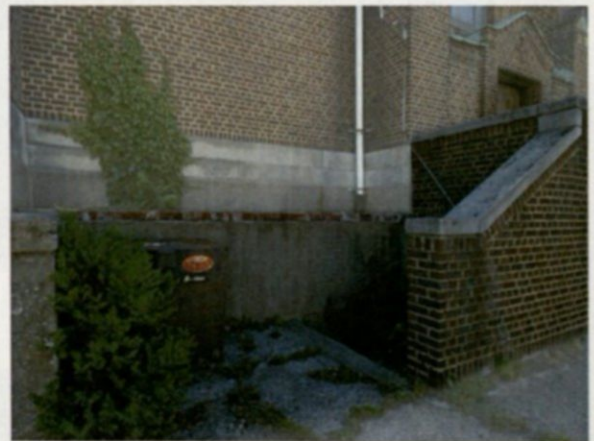
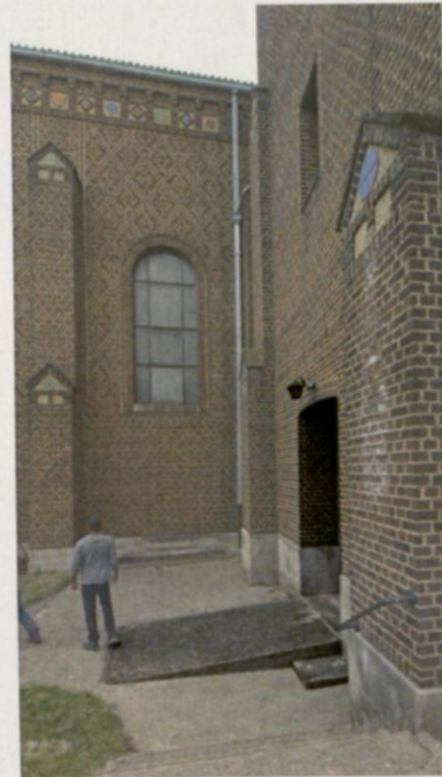
SIDE ENTRANCES

The sanctuary has various additional entry/exit points around the building. The campanile placement on the sanctuary hall forms a transept in which an additional side entry of double doors along Seymour Ave lines up with the campanile. This double-door side entry features a small porch with steps up to it, opposite of that are stairs down to the ground level. At the base of the campanile is an additional double door entrance with a segmented transom. A small ramp has been poured over top of the historic step up to the door. Along the southern facade of the building at the sacristy offices, there are two arched door openings with a single door floating above the ground level with a narrow step up. Along the western facade there is a stairwell with stairs that go down to a double door entrance to the ground floor level.

Besides the ramped entry at the campanile base, each of these side entrances do not meet ADA standards for accessibility. These historic entries should be preserved as much as possible with minor adjustments to be made to add to accessibility. The ground floor side entry on the western end is to have the historic railing and retaining wall removed as a new ground floor space will make this into an accessible route.

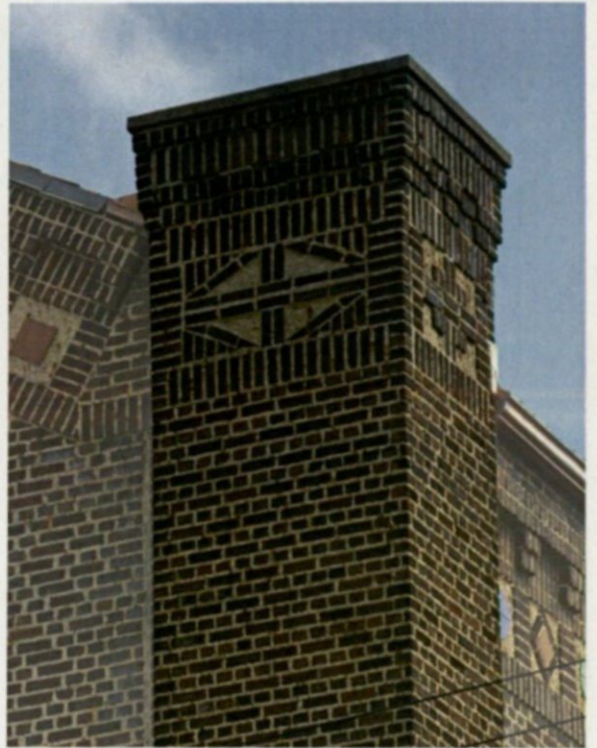
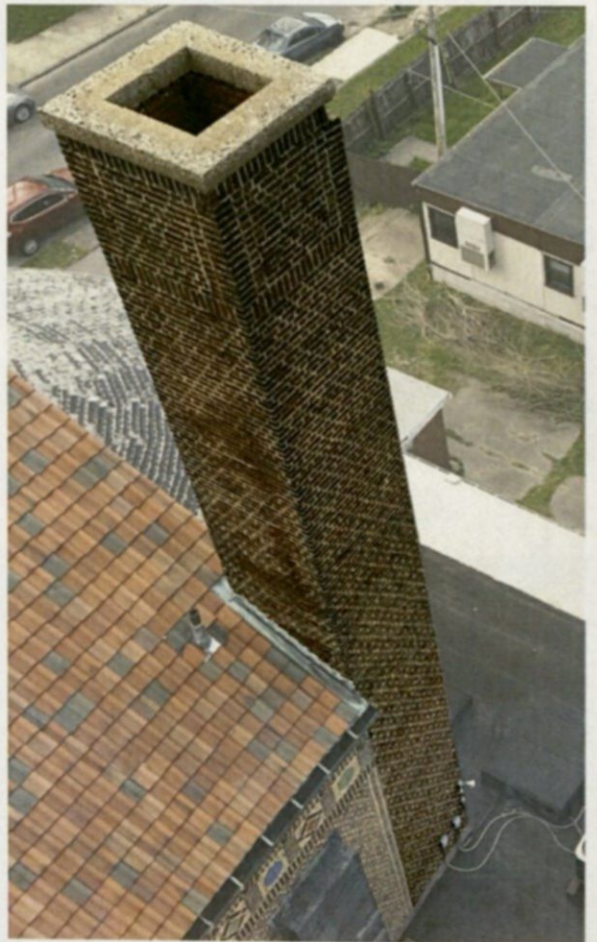
CORNER PIERS & CHIMNEY

The four corners of exterior of the nave are marked by three piers and a chimney stack. The corner piers project out slightly from the facade rising up slightly above the roof topped with a flat slab encircling these corners from the rest of the form. These piers feature decorative brickwork at the top that is framed in decorative patterns along with a cornice that supports the slab on top. The two corner piers at the northern front facade of the building feature stone bases that project out from the base framing the grand stair up to the narthex. The chimney stack rises up from the south-west corner of the building rising up above the rest of the building only dwarfed by the campanile that's adjacent to it. This chimney features a decorative brick at the top that forms an angled cross.

The corner piers are all in excellent condition while the chimney is in some damage. The chimney should be repointed and have missing bricks patched as well as have a new cap placed over top of it.

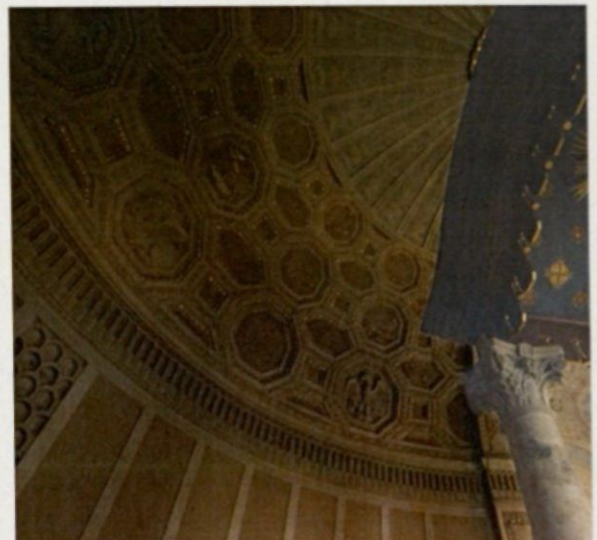
APSE

At the rear of the sanctuary, the apse emerges from the northern facade. The english course brickwork contrasts the diapered brick facade of the sanctuary that it emerges from. The upper horizontal band of the sanctuary wraps around the apse right marking the base of a pitched roof that tops off the apse. Historically this roof was terracotta but was replaced with asphalt shingles. At the interior the apse is decorated with decorative plaster at the ceiling and a gridded wall. Three door openings are located at the apse with an opening at each end and one at the center.

The apse is in relatively decent condition and should have any plaster damage repaired. New red-orange asphalt shingles should replace the existing roofing to match the color of the historic terracotta that once was. This element is important to both the exterior and interior character of the building and should not be altered in any significant way.

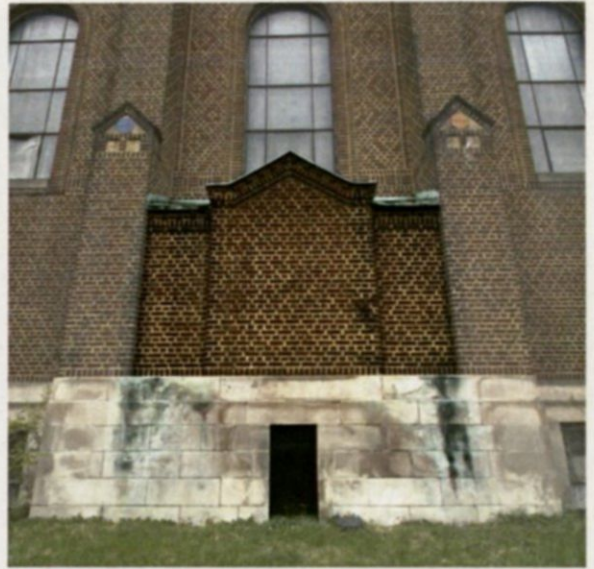
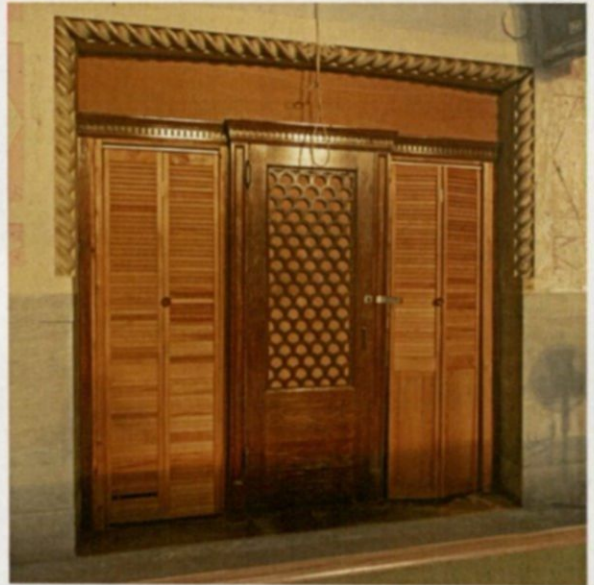
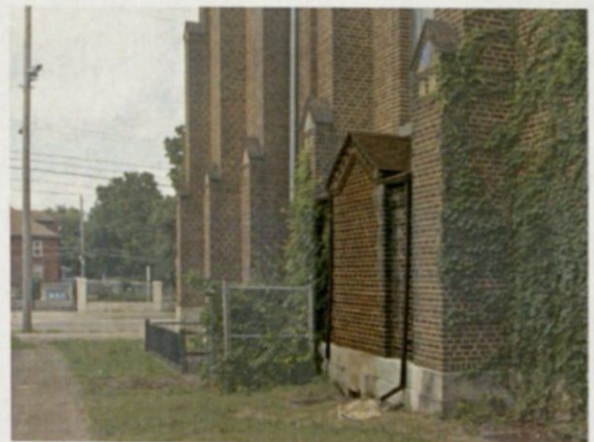
CONFESSSIONAL BAYS

Centered between the narthex bay and transept bay is a confessional bay that is marked with confessional booths projecting out from the nave on each side. At the exterior the confessional bays fill in between the buttresses topped with a cross gabled roof that sits below the defining horizontal brick band of the facade. The brick face of the confessional bays is topped with a brick cornice with the shingled roof peaking out from above. Centered at the base of the of the confessional bays is a long narrow opening infilled with a solid wood panel behind a wire mesh. The interior of the confessional bays features three openings, a center opening behind a decorative wood door that was for the priest and two side openings with small rooms that were formerly used by former parish members in their confessions. The side openings are behind a curtain on one side and have been refitted with folding doors on the opposite side. Above the openings of the confessional bay is a decorative wood cornice piece with a long narrow void above.

New orange-red asphalt shingles should replace the existing shingles on top of the bays. The side openings of the interior which historically had only been covered by curtains had been replaced with folding doors on one side. With the intention of using the space for storage, new folding doors should be added to the side openings. The void above the confessional booth should partially be infilled with speakers with new face panel with openings to infill the panel

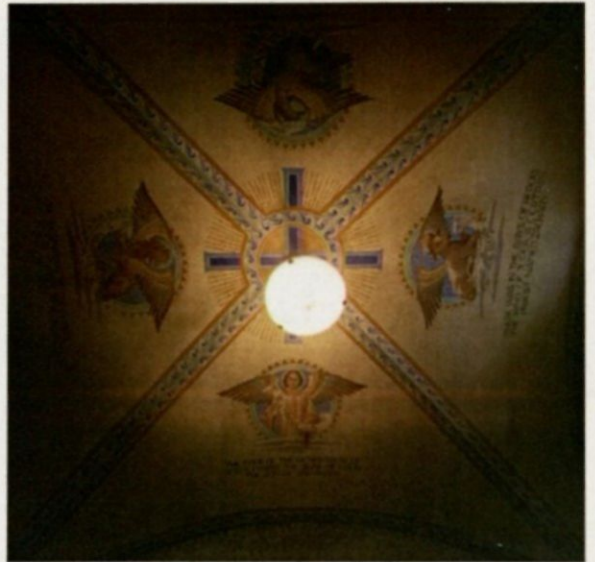
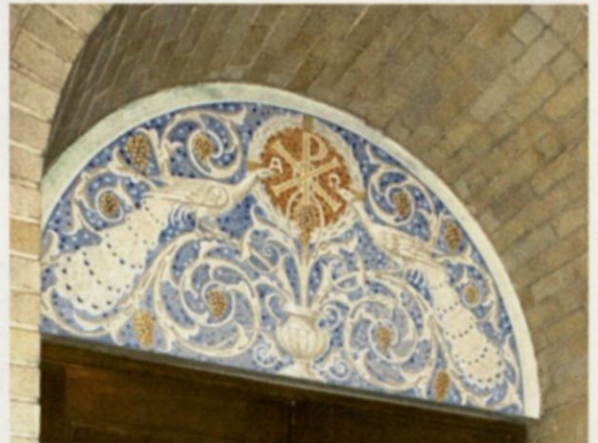
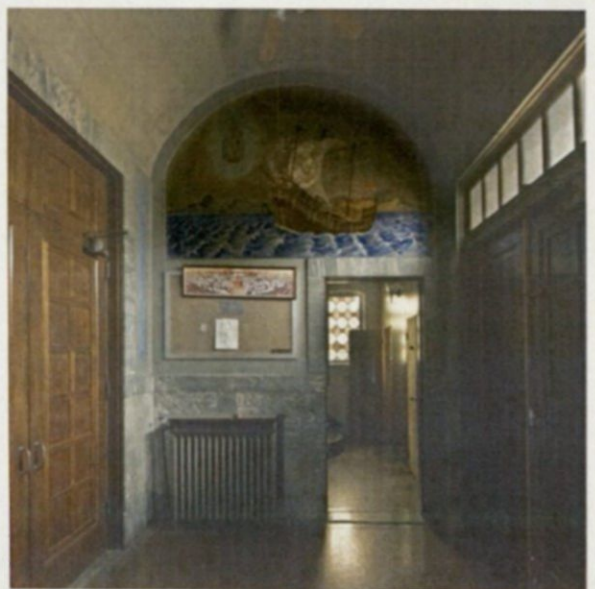
MURALS & OTHER PAINTINGS

Various murals are featured around the sanctuary building depicting biblical characters and scenes. At the first floor of the campanile there is a grand room featuring various murals located above the doors, window and on the vaulted ceiling. The vaulted ceiling features decorative painting along the ribs of the vault with a blue cross at the center of the ceiling with rays coming out from it. Four biblical characters are painted on each of the four segments of the vault accompanied with religious scripture. The two vaulted openings over the doors at the campanile base feature decorative paintings along with the arch over the stained glass window into the space. The entry vestibule of the narthex also features various murals with two large murals on either end of the narthex filling in the arch of the vaulted ceiling. Between each door are additional paintings along with small cherub sculptures that slightly project out from the wall. The rear chapel also features decorative painting at the edge of the ceiling where hand painted stenciling details line the transition where the ceiling meets the wall.

All of these murals are in near perfect condition with no repair necessary. These murals are hand painted and of artistic and historic value and should be preserved in place even though the religious component of the buildings program may not be present anymore. These murals highlight the religious history that this site while also honoring the historic art.

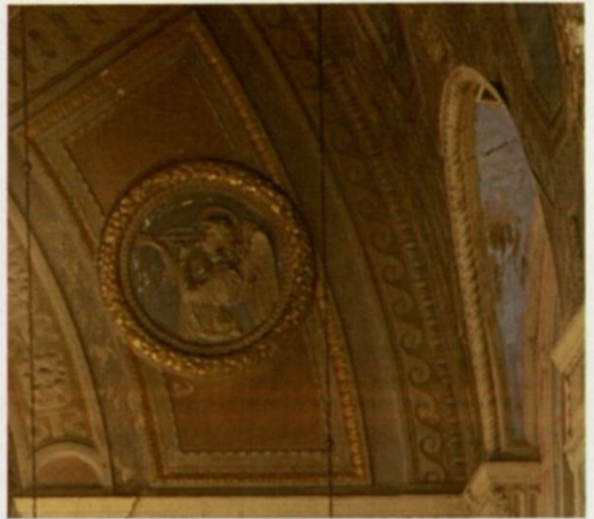
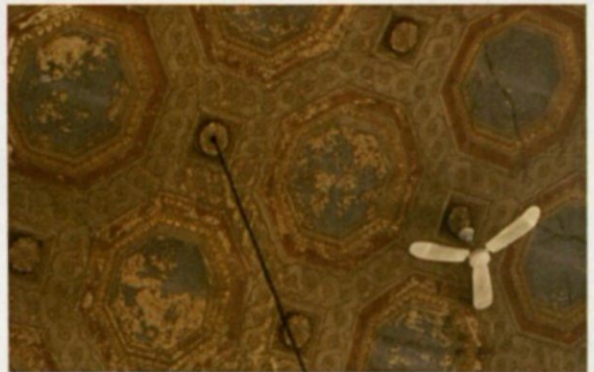
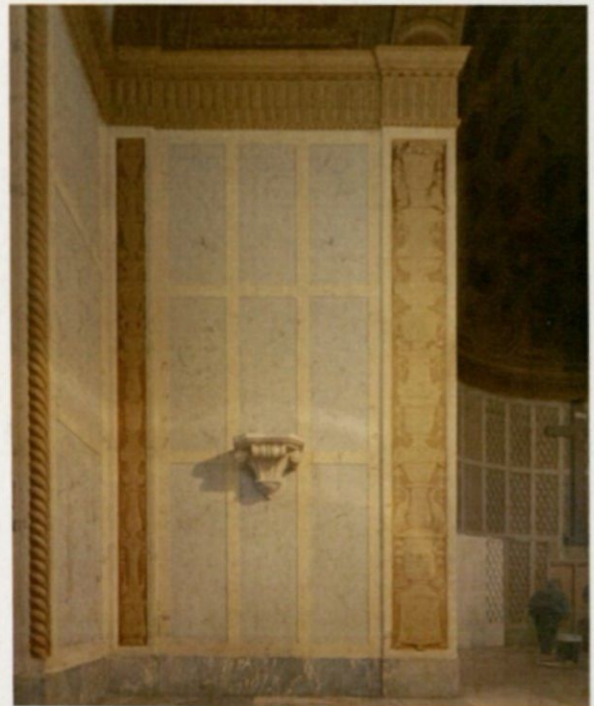
PLASTER DETAILING

Decorating the interior of the nave of the sanctuary hall is various intricately detailed plaster decals. The vaulted ceiling of the nave features a lucarnar style ceiling composed of various plaster decal pieces creating a geometric pattern composed of octagons and floral patterning. Each pilaster running down the nave is ornamented with twisting corner columns made of plaster that go up to the decorative plaster column head that marks where the wall ends and transitions into the vaulted ceiling. The southern wall of the sanctuary and apse features lots of intricate plaster detailing that frames ornamental plaster portraits of angels and other biblical figures that decorate the ceiling of the apse. More of these portraits can be found on the northern wall of the choir mezzanine where three scenes of angels are framed at the top of the mezzanine parapet wall with decorative floral details between them. The former baptismal room also features coffered ceiling composed of decorative plaster along with decorative plaster framing around the altar.

Various cracks have formed in the plaster walls and ceiling along with several holes in the ceiling and walls that need to be patched. Cracks in the plaster should be repaired with the intention of restoring the ceiling so plaster details do not fall from place. Holes in the plaster ceiling should be patched with a new smooth layer of plaster that is setback slightly from the historic plaster to emphasize the scarring and history of the building. Lower plaster walls should be painted a uniform off-white color to brighten the space while the historic paint at the ceiling should be left in tact with minor repairs where it was painted white.

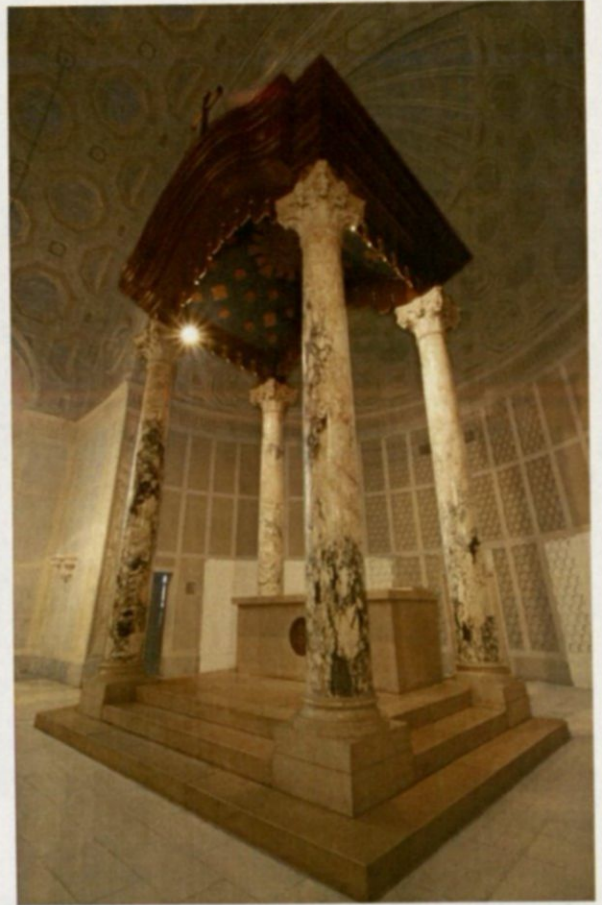
BALDACHIN & OTHER ALTARS

Various historic altars are still in tact from various eras in the churches history. The original main altar is still in tact on the chancel though has been modified to add a baldachin canopy in 1953. This baldachin is composed of four marble columns with corinthian columns at the head supporting a decorative wood roof piece that is decorated with various christian symbols at the top such as the cross and underside with the painted mural. In the former baptismal, there is an altar along the northern wall composed of a two marble columns and a small stand in front of a framed opening in the wall where marble paneling is slightly setback into the wall. In the southern chapel there is an additional altardating to the 1960s according to drawings the church has showing plans for the altars design. This altar is compose of a light marble and has eight marble columns supporting a plinth with a tabernacle set on top of it. Mounted on the wall above this is a round portrait scuptural piece depicting Baby Jesus and his mother.

These altars are all in excellent condition and should be kept in tact as they are decorative elements important to both the history and character of the buildings. New light fixtures should be installed at the baldachin to allow for it to be used for lighting. Preserving these altars allows for these spaces to still be rented out by religious organizations if they need a larger space for an event.

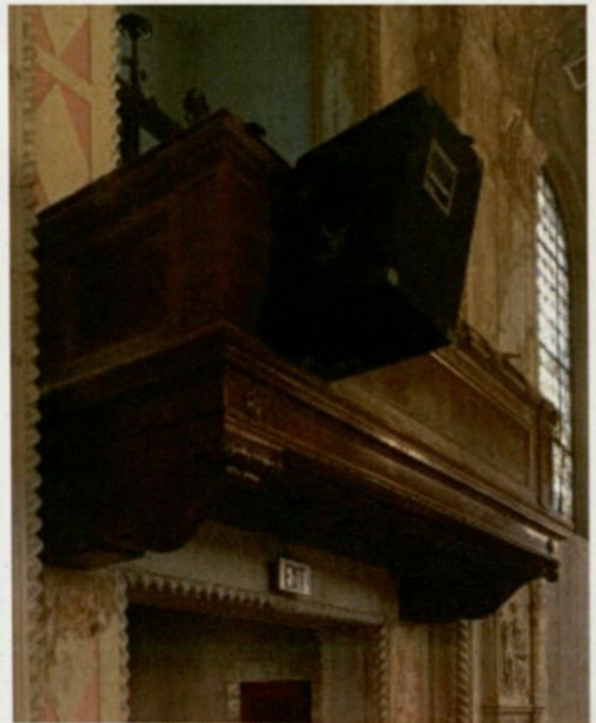
ROOD SCREENS & BALCONY

Aligning with the transept is a balcony that opens up the nave into the interior of the campanile. This wood balcony features decorative wood detailing such as a coffered ceiling on the underside of the balcony. Two supports jut out at the ends of the balcony that are covered by decorative wood details. This balcony has a tall steel rood screen on the other side of it featuring a sliding door at the center. This rood screen doors are adorned with framed quatrefoils going up to a horizontal band that features decorative steel work. This band is topped off with decorative steel elements. Another rood screen is located at the entrance to the former baptismal, these rood screen doors are adorned with a simpler quatrefoil pattern and are sliding doors. A decorative horizontal band sits atop these doors with a steel cross sitting at the top center with smaller decorative elements on either side of the cross.

These rood screens are in excellent condition and should be preserved as is with a new coat of dark paint. A new solid transom window should be inserted above the former baptismal rood screen to enclose that space more properly. The wood balcony has been damaged by water that came through the roof. As much of the existing balcony should be salvaged as much as possible.

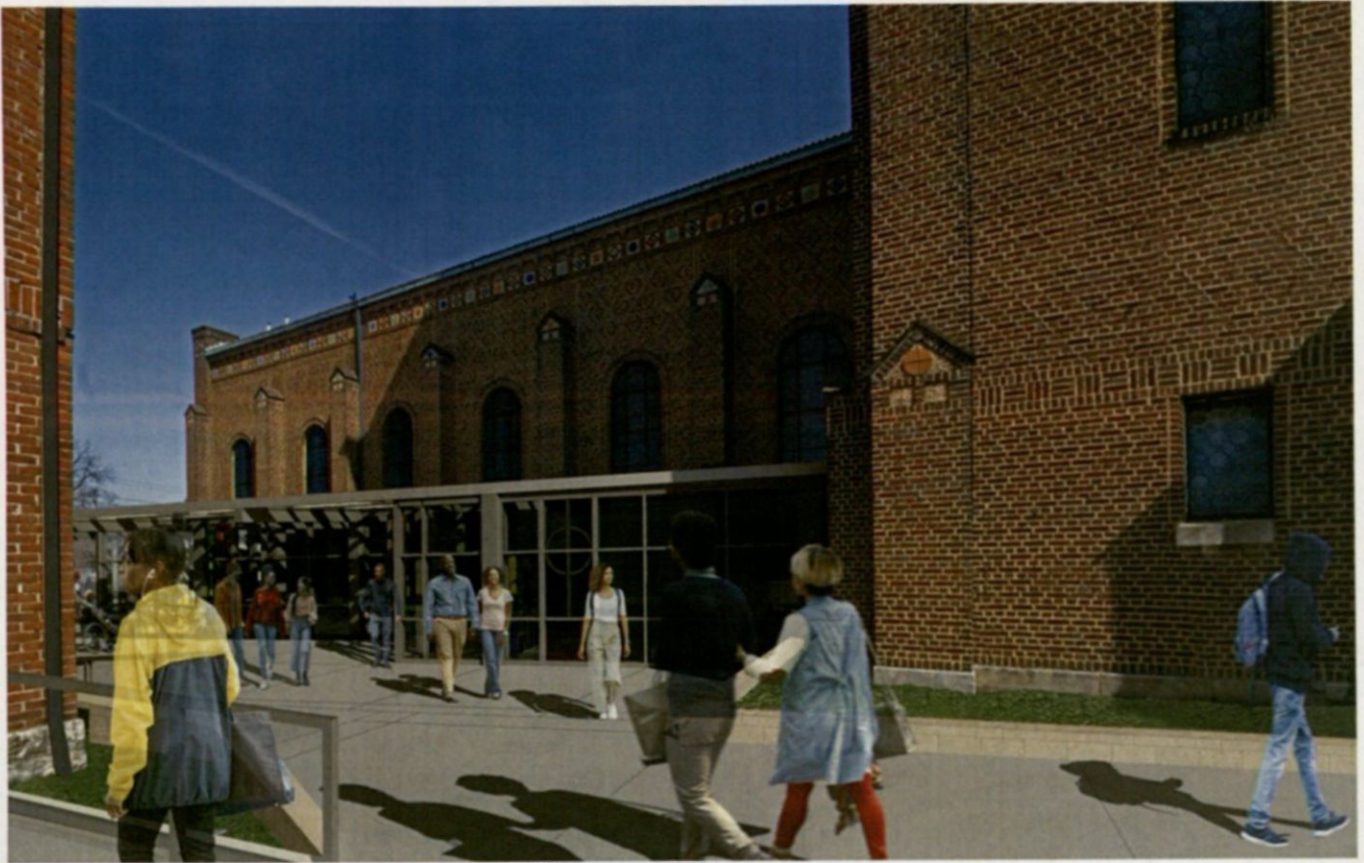
ADDITIVE STRUCTURE - EXTERIOR VIEW AT COMPRESSION POINT

ADDITIVE STRUCTURE SLOPED BELOW THE LOWER HORIZONTAL BAND

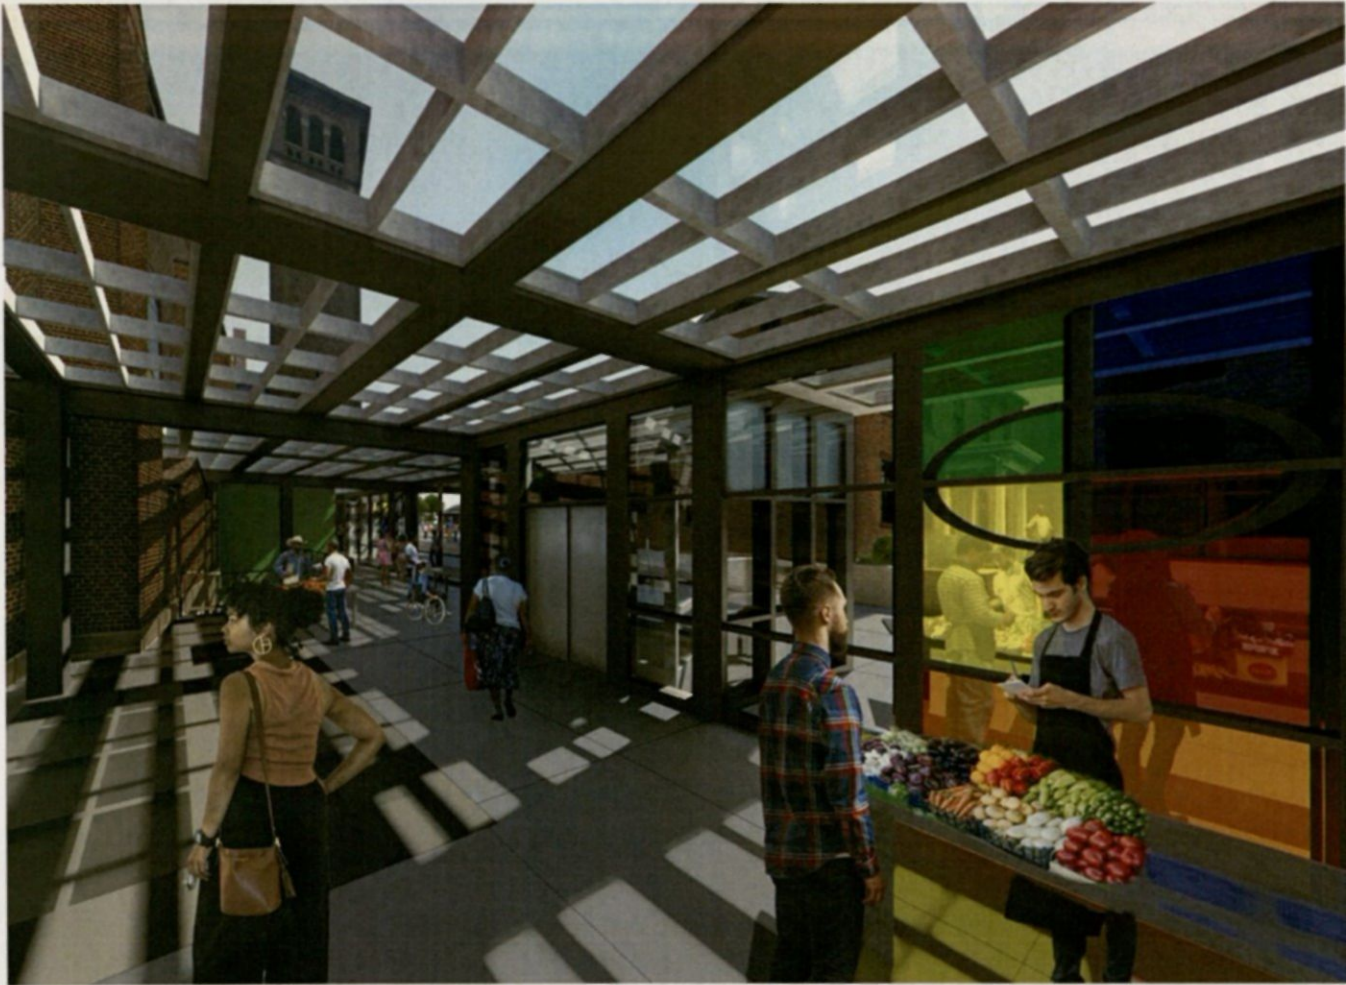
ADDITIVE STRUCTURE - INTERIOR SCENE DURING A FARMERS MARKET

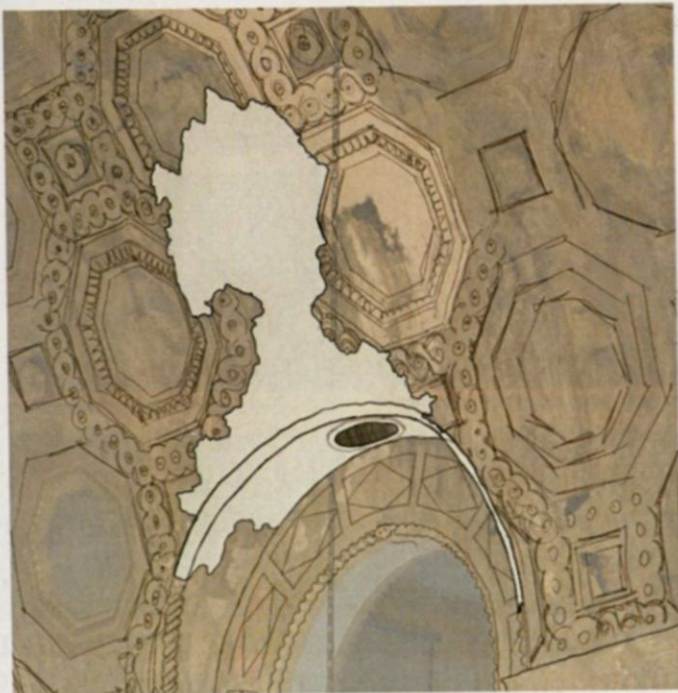
**WEST TRANSCRYPT CEILING
DAMAGE REPAIR**
NEW SMOOTH LAYER SET BACK
SLIGHTLY FROM HISTORIC PLASTER

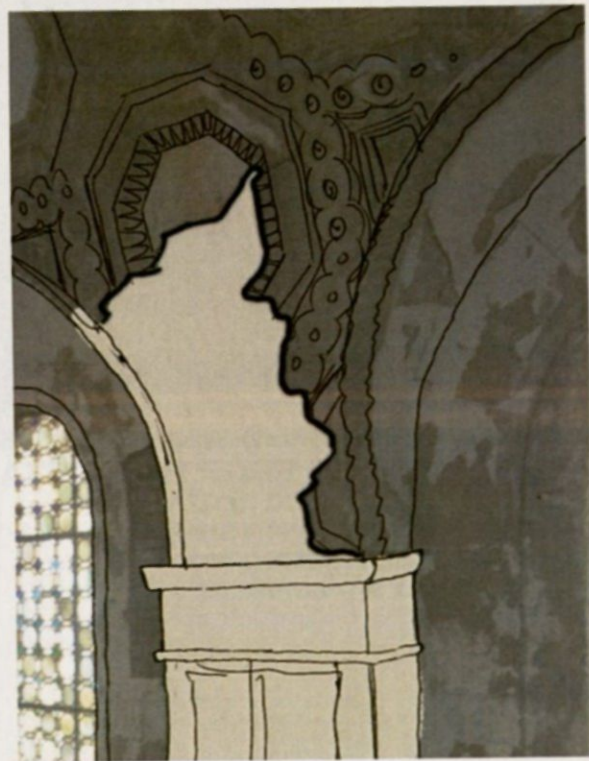
**REPLACEMENT FOR DAMAGED
PILASTER HEAD**
NEW SIMPLIFIED COLUMN HEAD TO
DIFFERENTIATE NEW ELEMENT TO
REPLACE ONE LOST TO TIME

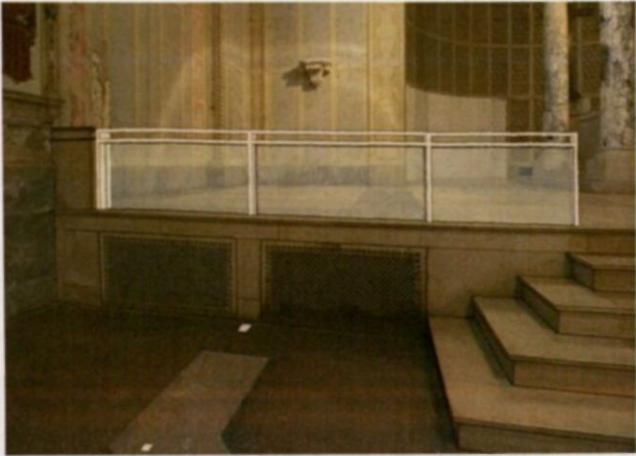
RAISED FLOOR EDGE RAIL DETAIL
 TIE NEW RAILING INTO REMENENT OF
 HISTORIC RAILING WITH SIMPLE
 MODERN STEEL RAILING WITH
 GLASS INFILLING BETWEEN

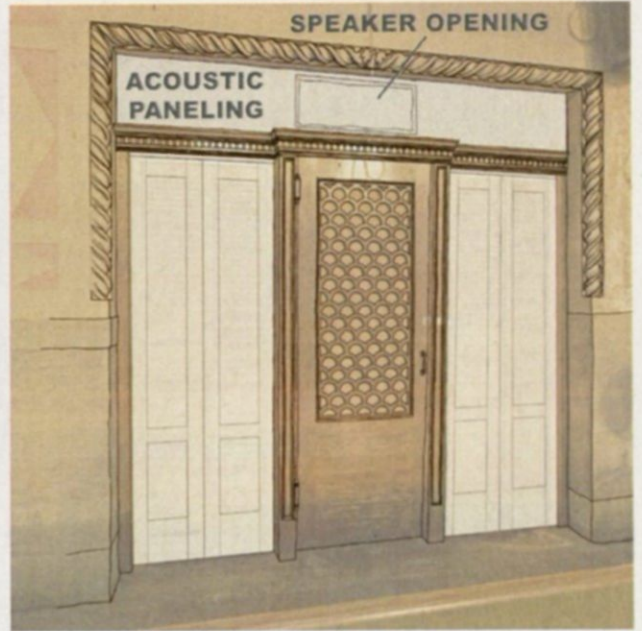
FORMER CONFESSION BAY DETAIL
 NEW SIMPLIFIED COLUMN HEAD TO
 DIFFERENTIATE NEW ELEMENT TO
 REPLACE ONE LOST TO TIME

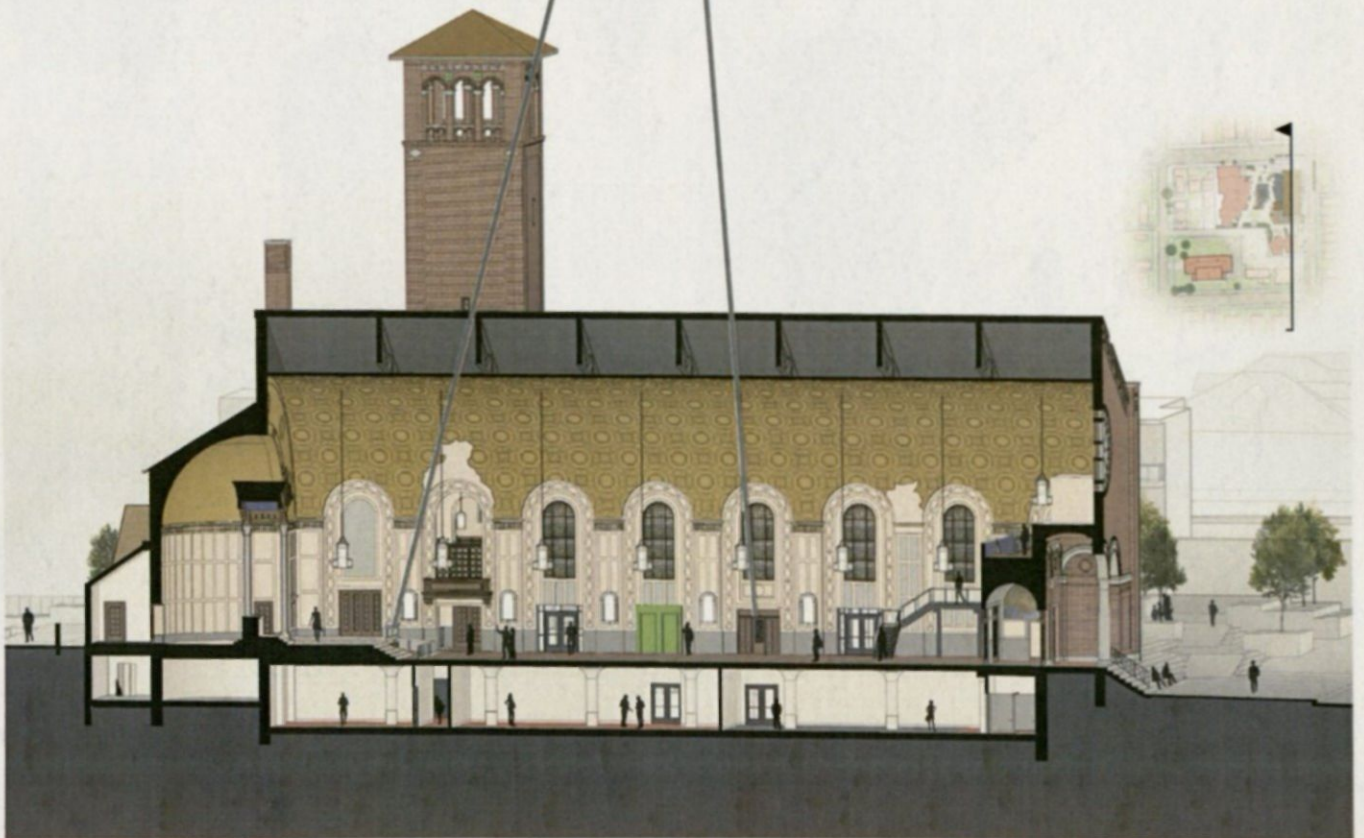
OPEN TO BELOW EXPOSURE
FULL STAINED GLASS WINDOW

**PRESERVE CEILING PAINT,
REPAINT SMALL PORTIONS
THAT HAVE BEEN
PAINTED WHITE**

**ACOUSTIC
PANELING**

**PRESERVE HISTORIC
LIGHT FIXTURES**

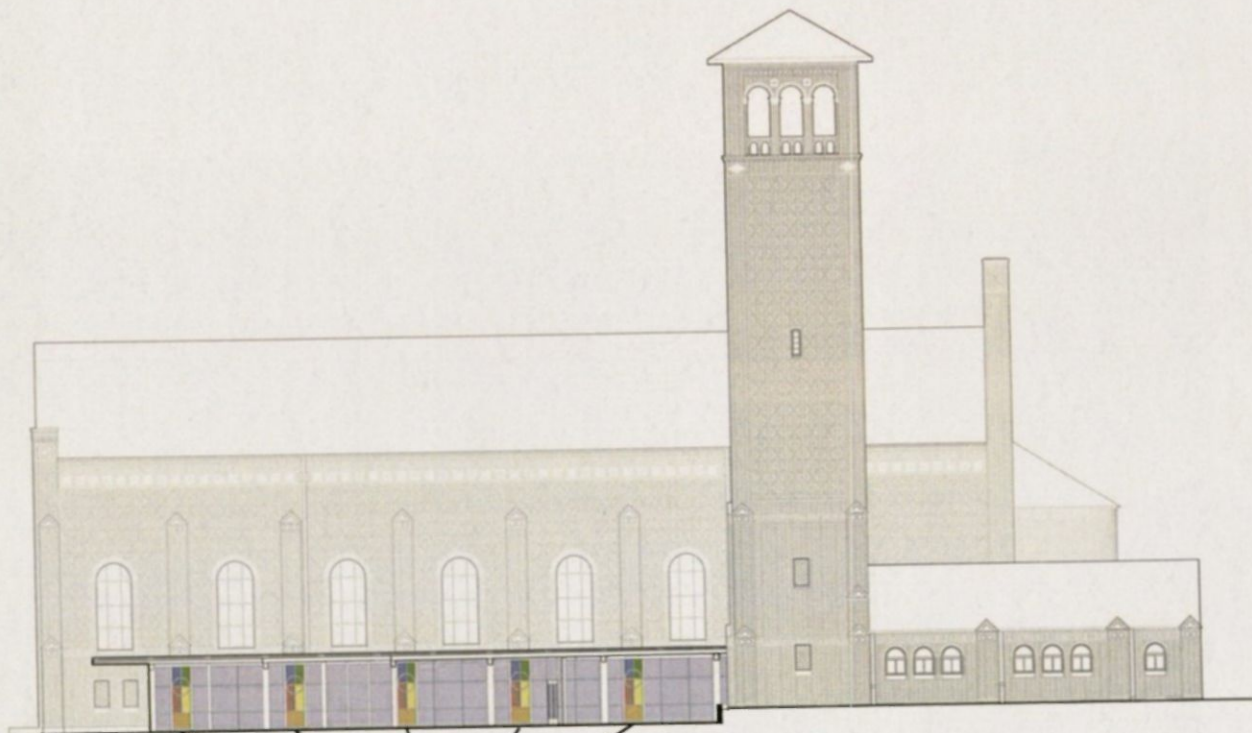
**STAINED GLASS ELEMENTS
ALIGNED WITH BUTTRESSES
FEATURING COLORS FOUND
IN HISTORIC ARCHITECTURE**

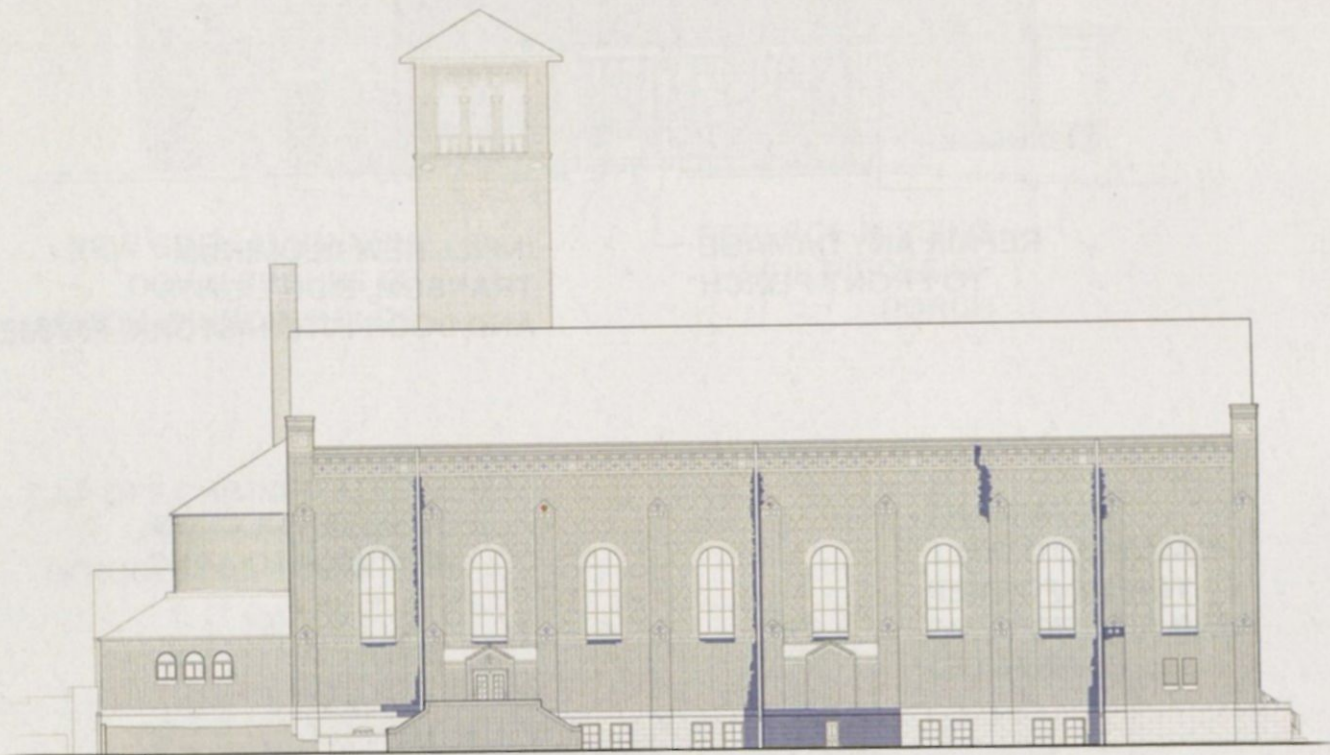
REPOINT MASONRY JOINTS

PATCH DAMAGED OR MISSING MASONRY

**NEW ASPHALT
SHINGLED ROOF**
